# ADOPT-A-BEACH PROGRAM

## Long-Term Monitoring of Camping Beaches in Grand Canyon

*A Comparative Examination of the Results for Eight  
High Flow Experiments in Grand Canyon, 1996 - 2018*

*March 4, 2022*

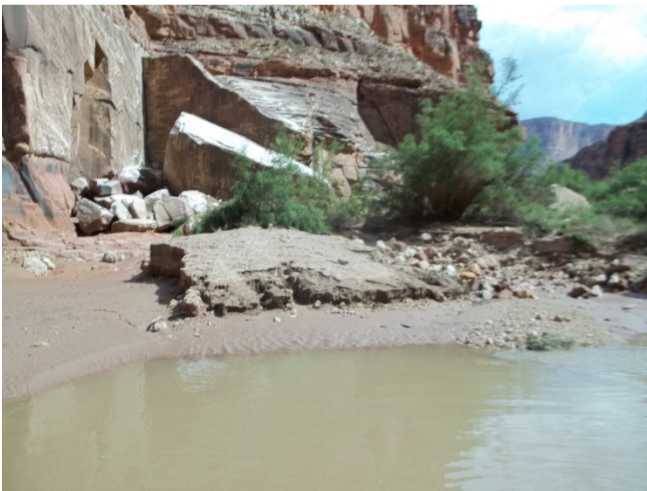
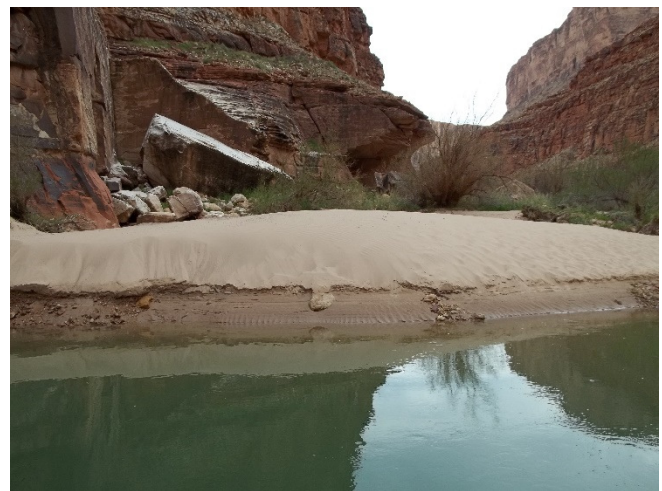
*Hot Na Na Camp, RM 16.6L*

*Example of camp restoration resulting from the early November 2018 High Flow Experiment event.*

*Photo on left taken July 19, 2018, on right April 1, 2019*

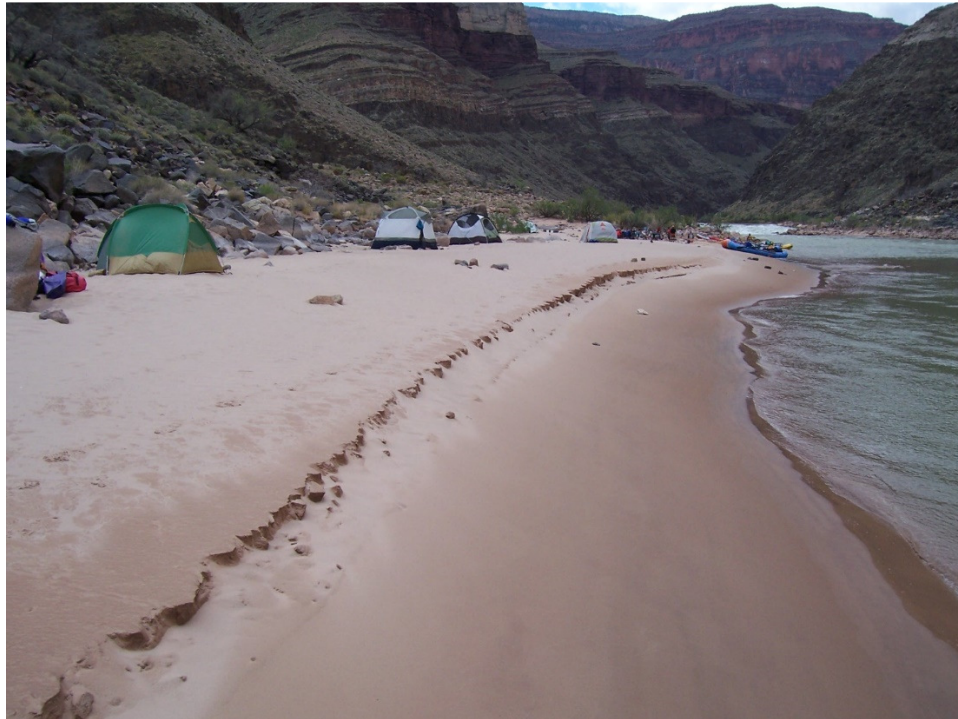
Figure 21. An example of an Improved camp following an HFE. Stone Creek, RM 132.5 R, April 11, 2012.

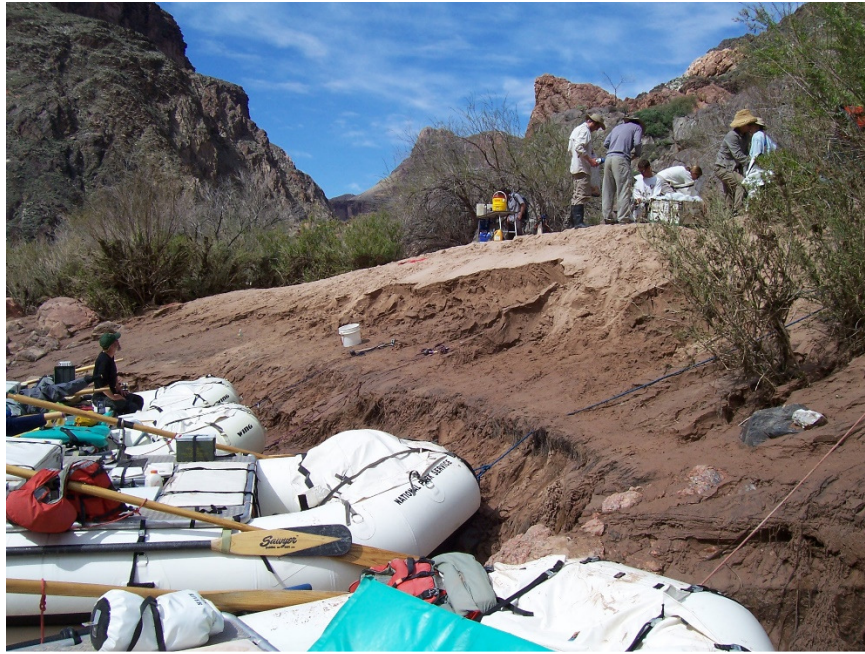
*Figure 22. An example of water draining from beach immediately following an HFE, undermining the sediment deposition. Crystal RM 98.7 R, March 12, 2008.*

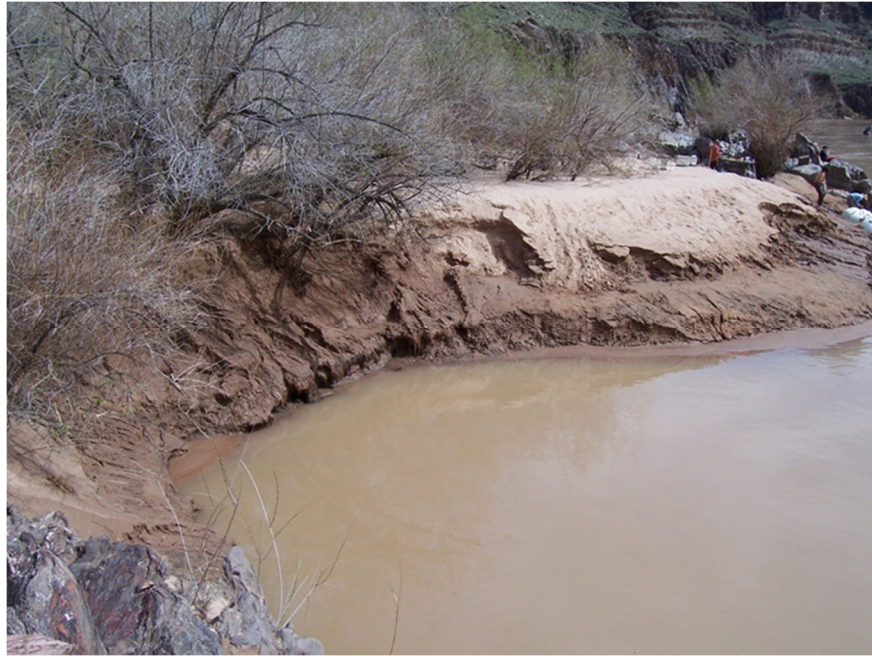
*Figure 23. Beach being undermined by water drainage after HFE due to quick downramp.  
Bass Camp, RM 109.1 R, March 14, 2008.*

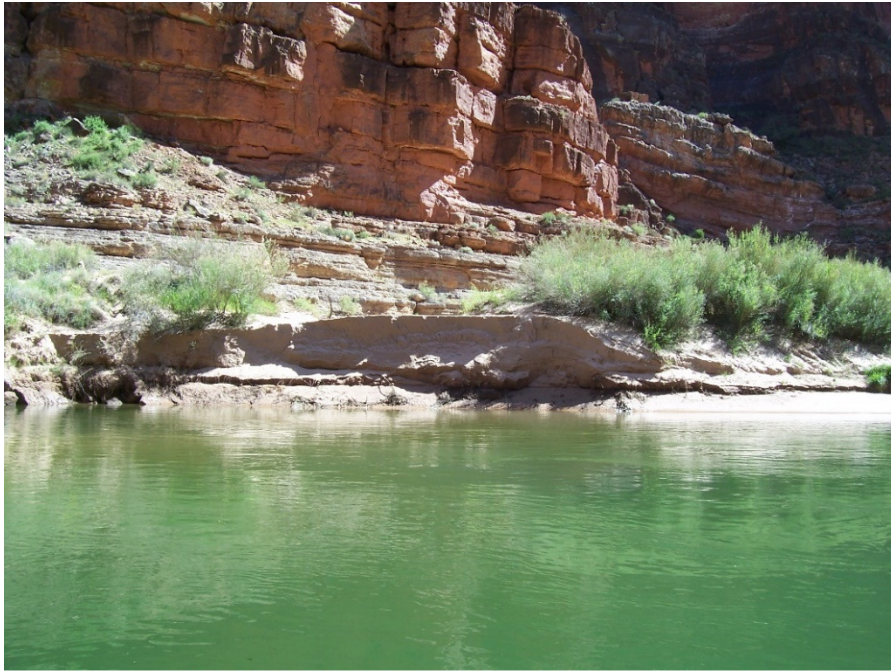
*Figure 24. Documentation of beach access Degraded (Nonexistent) after HFE due to quick downramp and fluctuating flows. Tatahatso Camp, RM 38.6 L, April 3, 2015*

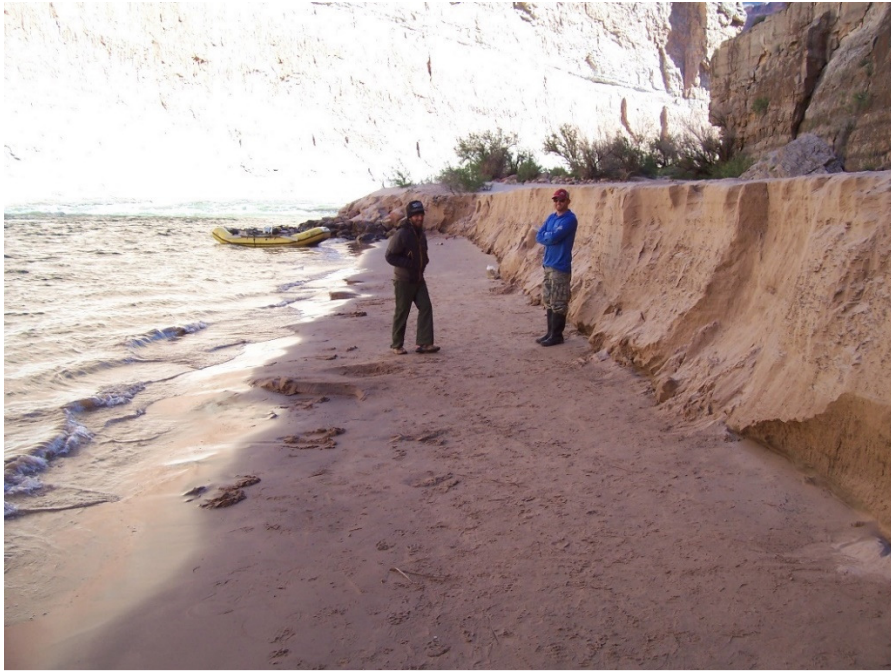
*Figure 25. Documentation of beach access seriously hindered after HFE due to quick downramp and fluctuating flows. The campable area did increase significantly and had good access (behind photographer), so received an Improved rating.  
Shinumo Camp, RM 38.6 L, April 3, 2015*

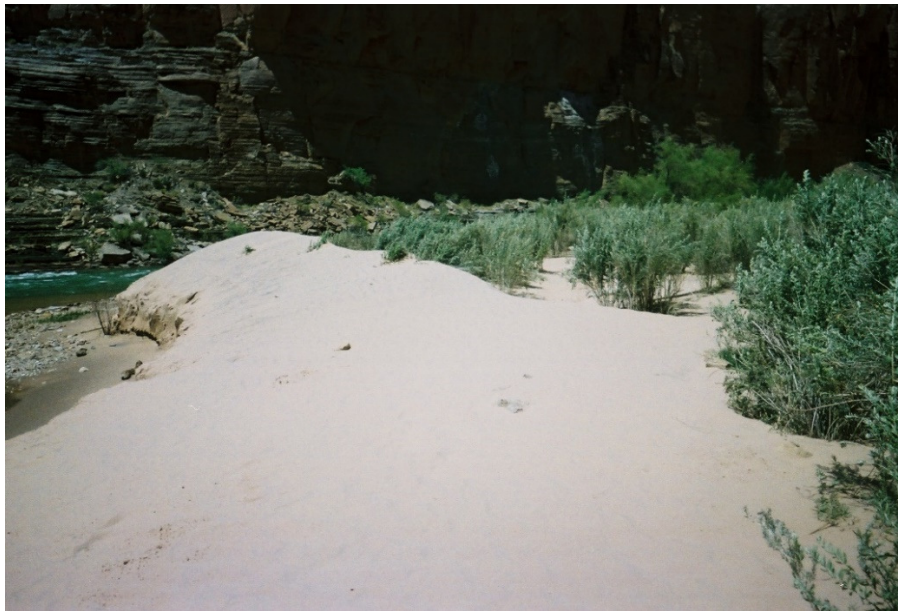
*Figures 26. Documentation of mounded sand deposition followed by beach front shear, March 2008 High Flow Experiment resulting in a Degraded classification.  
Lower National Camp, RM 167.11 L, June 17, 2008.*

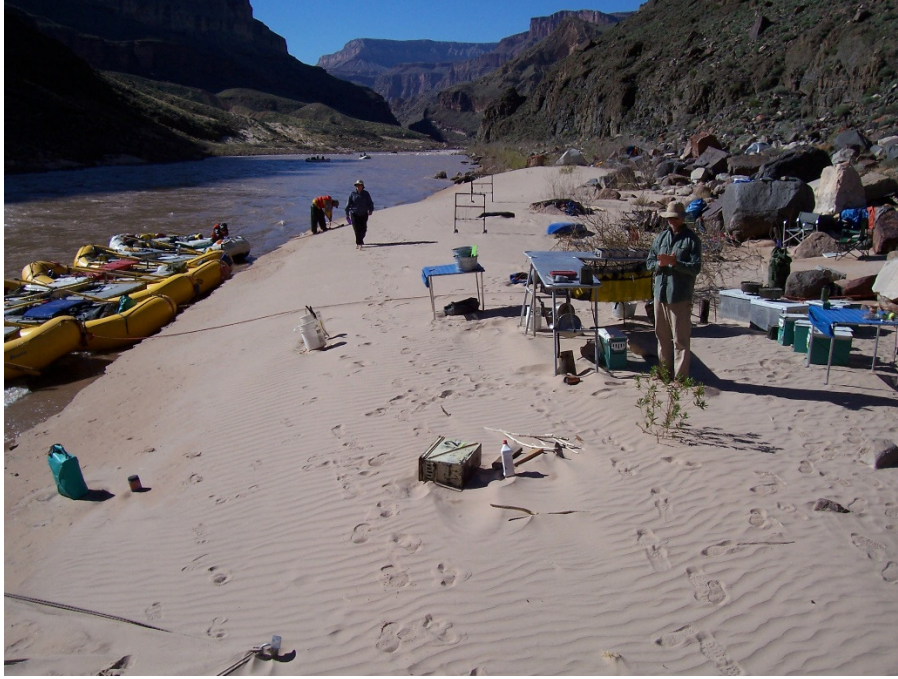
*Figure 27. Documentation of a successfully Improved camp. Lower Tapeats, RM 134.5 R, March 15, 2008*

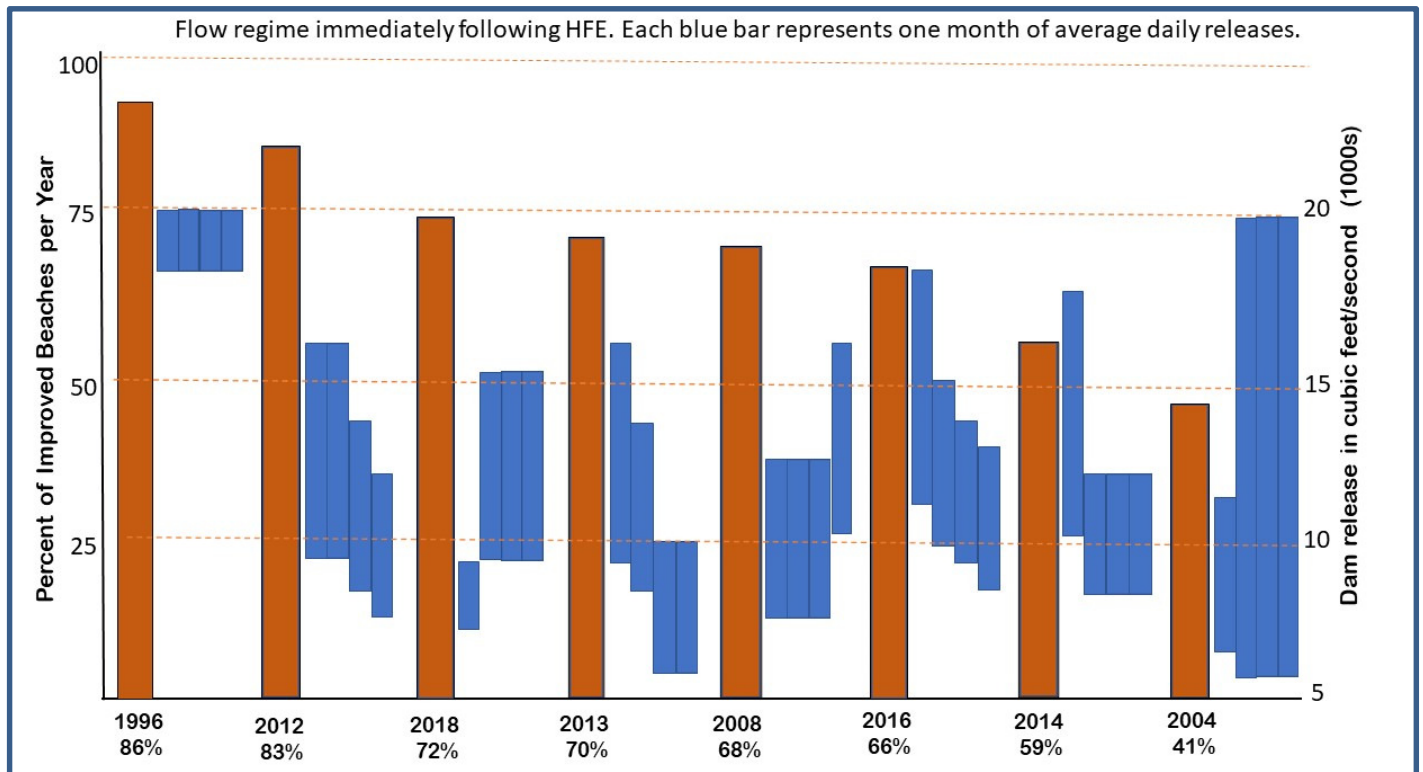
Figure 28. Distribution of Improved results and the approximate daily fluctuating flows for the four months immediately following the HFEs.

Fluctuating flow releases have been proven to degrade beaches (Mueller, 2018). And the higher the flow rate, coupled with an increase in the daily minimum to maximum cubic feet/second, the greater the negative impact on beaches. As shown by the graph in Figure 28, it may be possible that there is an inverse correlation between the observed success of each HFE, as expressed by percent of Improved beaches for that year, and the flow regime closely following the event. The lowest rate of success years are generally the same ones that have the highest flow releases and greatest fluctuations between the end of the HFE and the acquisition of the photos. The lowest rate of success, 41% in 2004, had the highest releases and greatest fluctuations in the 3 months preceding the photo dates at 5500 to 20000 cfs daily, 14000 cfs plus/minus in a twenty-four hour period. The next two lowest percentages, of 59 and 66, for 2014 and 2016, had periods of releases topping at 18,000 cfs, with daily fluctuations between 6000 and 8000 cfs. As has been stated, high flows and wide fluctuations have been proven to degrade beaches rapidly no matter how substantial the deposition. The 86% success for the 1996 event, although followed by the extremely high daily release rate of 20000 cfs, can be explained by the facts that the high release was consistent for the five months following the HFE when the beach photos were being taken, and that the fluctuation was only 2000 cfs daily, down to 18000. Additionally, the lower part of the beaches were never exposed for evaluation until late in the season. It also is significant that this was the first HFE and any increase in sand deposition recorded was probably considered as a positive outcome.

The three years with Improvement percentages clustered between 68, 70 and 72, in 2008, 2013 and 2018 respectively, had reduced maximum releases of 16000 cfs, and a low daily fluctuation of 3-5000 cfs. Two of these years, 2008 and 2018, had steady, medium daily fluctuations for the months following the event, which undoubtedly helped slow degradation of the camps during the photo acquisition period. Second only to 1996, 2012 had an 83% success rate. It also saw a high flow of 16000 cfs with medium fluctuation rates for the two months after the fall HFE, then the high flows and fluctuations were reduced twice before the early season photo period, ending with a daily high release of 12000 cfs and a fluctuation of 4500 cfs or less in the month prior to photo acquisitions. It is possible that the beach fronts had time to settle and grade by early summer to present more favorable conditions for boaters.
