Long Term Monitoring of Camping Beaches In Grand Canyon

Summary of Results for the Year 2009 with Comparisons to Pre 2008 High Flow Experiment

***Annual Report of Repeat Photography
By Grand Canyon River Guides, Inc.¹
(Adopt-A-Beach Program)***

August 30, 2010

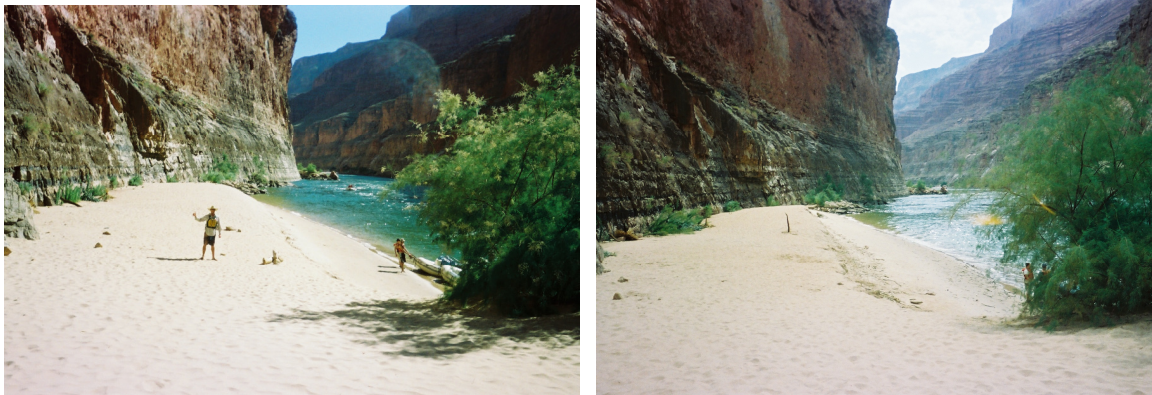
Figures 3 & 4. Recession of beach front following July increase in fluctuating releases, camp at Shinumo Wash, RM 29.5 L. Left photo 6-21-09, right photo 8-31-09

There were 11 of the camps (31 %) receiving a designation as being degraded during the summer. The factor cited as being the primary contributor of degradation is erosion from fluctuating river flow. This was markedly noticeable following the ramp-up of releases in early July and the subsequent increase in the mean of the daily flows. Increased vegetation and aeolian effects were noted as secondary factors, and were minor in comparison.

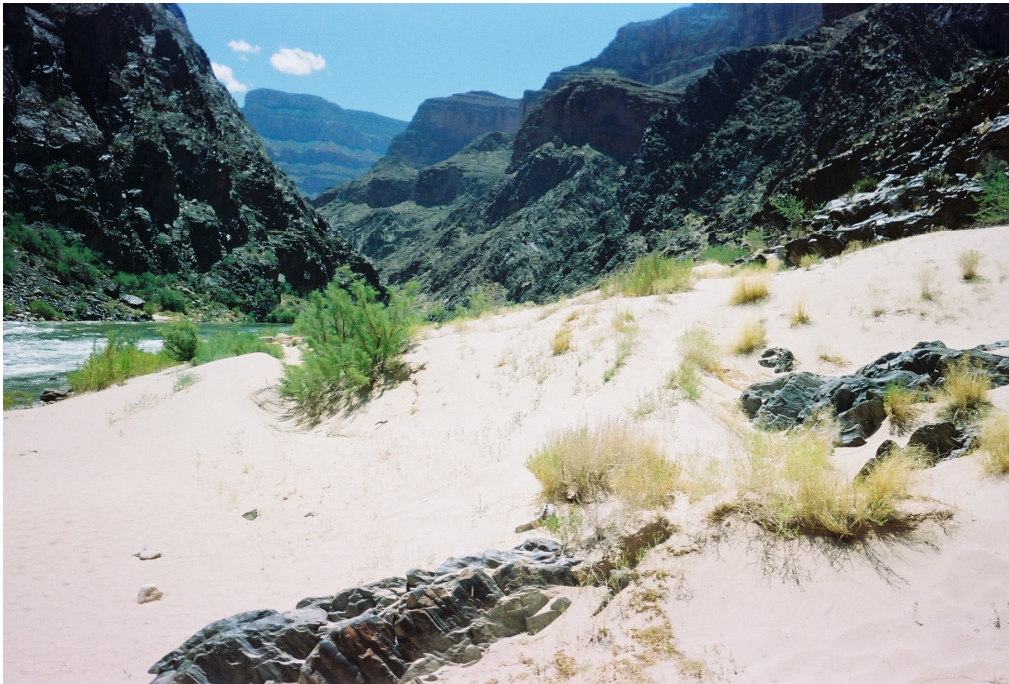
Figure 7. Dune creation (left) and expansion (right) at the upper end of Boucher camp, RM 97.2 L, 7-19-09 .

The most frequent observation, which occasionally resulted in a down grading of the beach, is the huge increase in dune formation on or near the camp areas. This often reduced the campable area at a beach and, in a couple of instances, inhibited the ability of larger groups with many boats to park together.

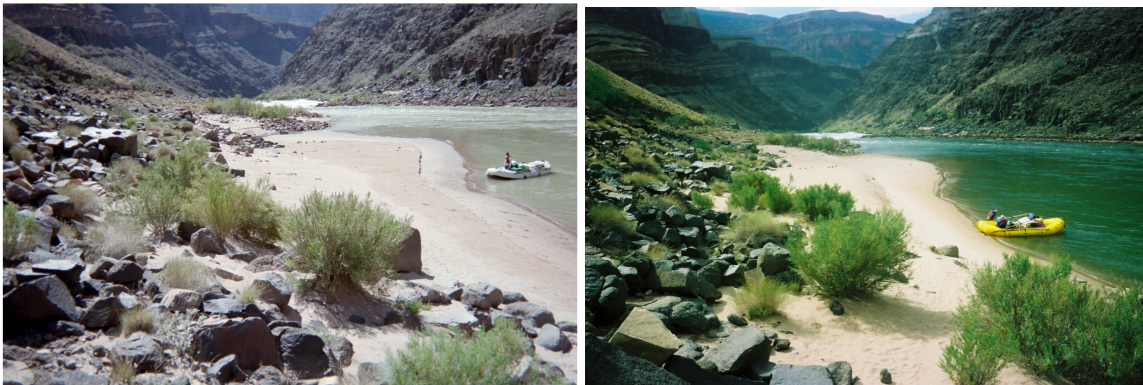
Figures 8 & 9. Stone Creek Camp, RM 132.5, is a camp that suffered serious erosion in late 2009, yet remains improved compared to Pre-2008 HFE. The photo on left is from 9-28-07, the right was taken 9-13-09.
