Adopt – A - Beach:

Long Term Monitoring of Camping Beaches in Grand Canyon

Summary Report of Observations for Fall 2010

Grand Canyon River Guides, Inc

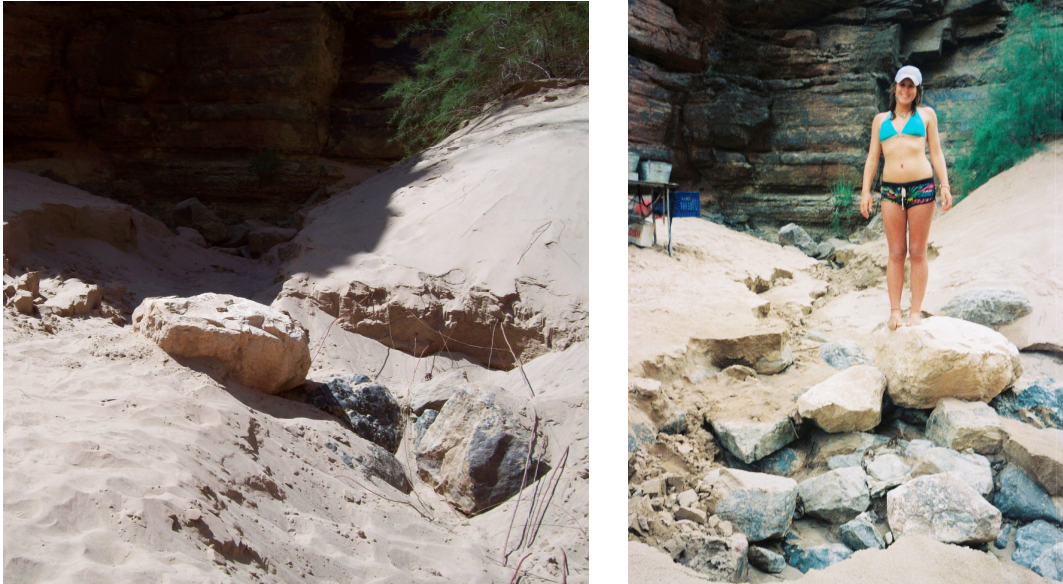
Figure 2 & 3. Matkat Hotel RM 148.9 L. Photo on left taken 4/11/2010, right taken 8/2/2010. Documented change in rain erosion gully for 2010 season.

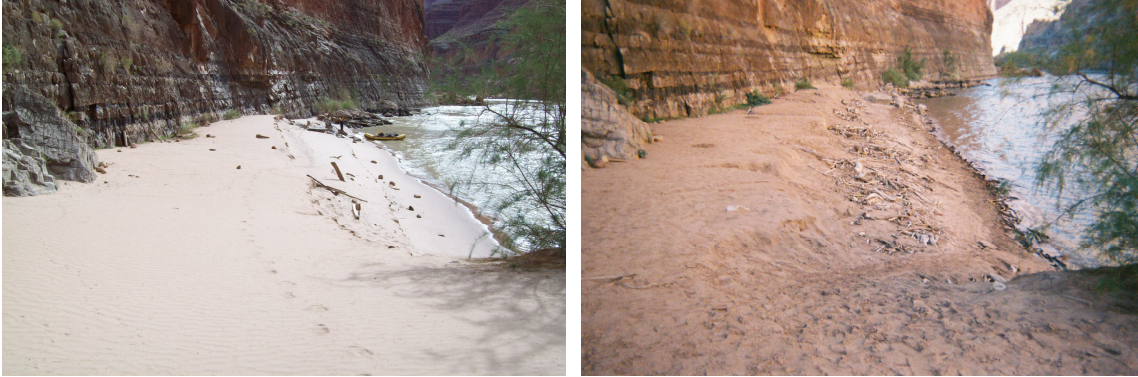
Figure 3 & 4. Shinumo Wash, RM 29.5 L, 04/02/10 (left) and 10/19/10 (right) display multiple factors of degradation including beach recession from river erosion, rain gullies and erosion from human use.

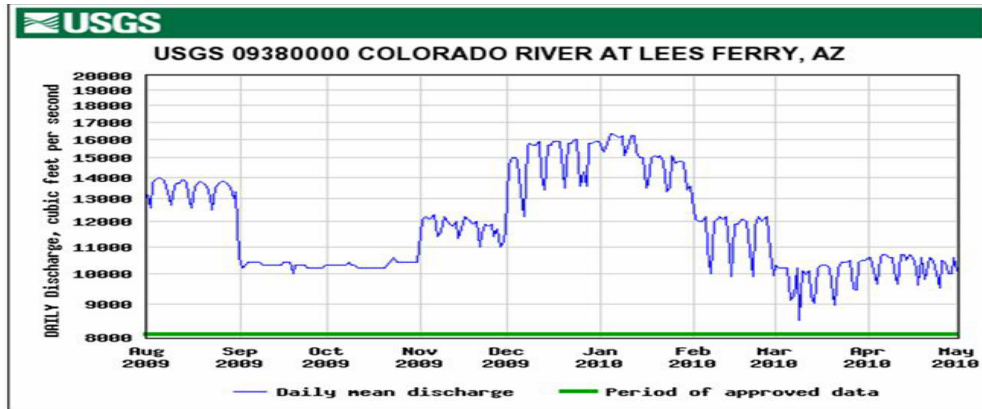
Figure 6. Flow graph for Colorado River at Lees Ferry, AZ., 8/2009-4/2010

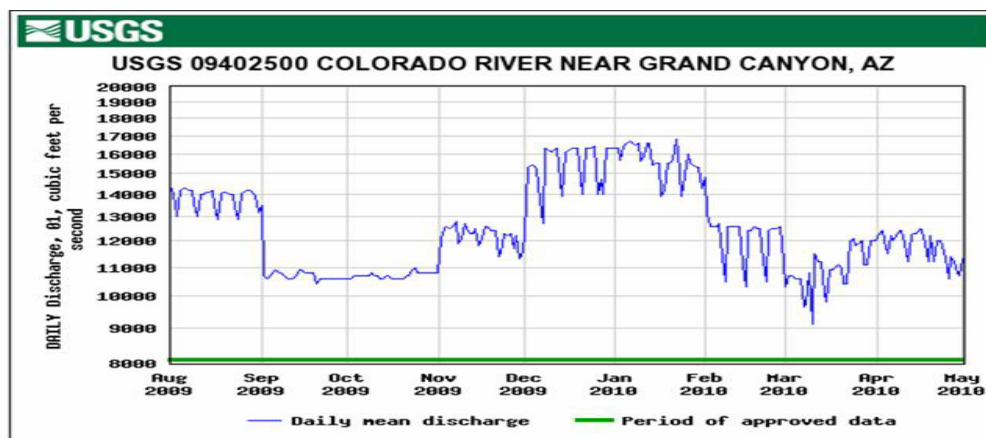
Figure 7. Flow graph for Colorado River near Grand Canyon, AZ., 8/2009-4/2010

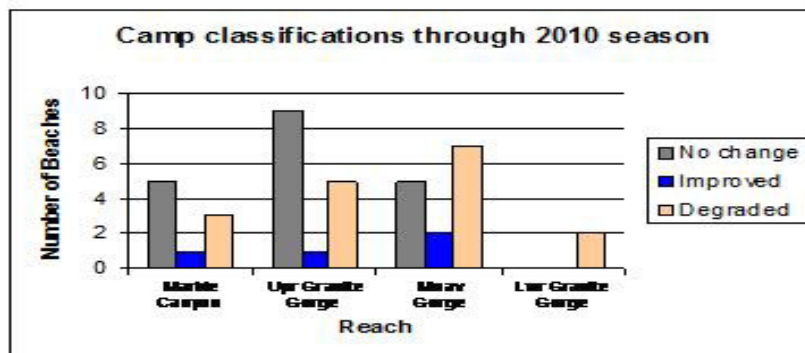
For the time spanning the 2010 summer boating season, early April to late October, 40 of the 44 study beaches in the program had photographs and photographer comment sheets spanning a sufficient period of time to be evaluated. Of these 40 beaches, 47.5% were classified as Unchanged for the time period, 10% had Improved through the summer and 42.5% were considered as Degraded by the end of the season. Of the Unchanged beaches, 12.5% are located in the Marble Canyon reach, 22.5% in the Upper

Granite Gorge reach, another 12.5% are contained in the Muav Gorge reach and none are from the Lower Granite Gorge. Two and one-half percent of the Improved beaches, or one beach, are located in the Marble Canyon reach, another 2.5% in the Upper Granite Gorge and 5% are found in the Muav Gorge reach. Again, none are located in the Lower Granite Gorge. For the beaches classified as Degraded for this time period, 7.5% are from the Marble Canyon reach, 12.5% are found in the Upper Granite Gorge, 17.5% in the Muav Gorge reach and 5% are located in the Lower Granite Gorge reach. The primary factor cited as creating an Improved camp is an increase of sand on the beach front enlarging the beach and creating more favorable parking for boaters. This is attributed to deposition from river transported sediment or sand being moved downslope and forward to the beach front by multiple actions. While gully erosion from rain events late in the season are the most readily evident cause of Degradation, other primary factors cited include cutbanks associated with river fluctuation, vegetation encroachment and impacts from people. The cutbanks are found equally on beach faces running parallel to the river current and on the furthest upstream end of the return channel. The later incidents are most often associated with beaches where the camps are located in this same area. Besides erosion by continuous tracking on a particular pathway, other human impacts noted by volunteers included littering and intentional modification by constructing steps in embankments to access the river.

Figure 8. Graphic illustration for 2010 seasonal evaluations

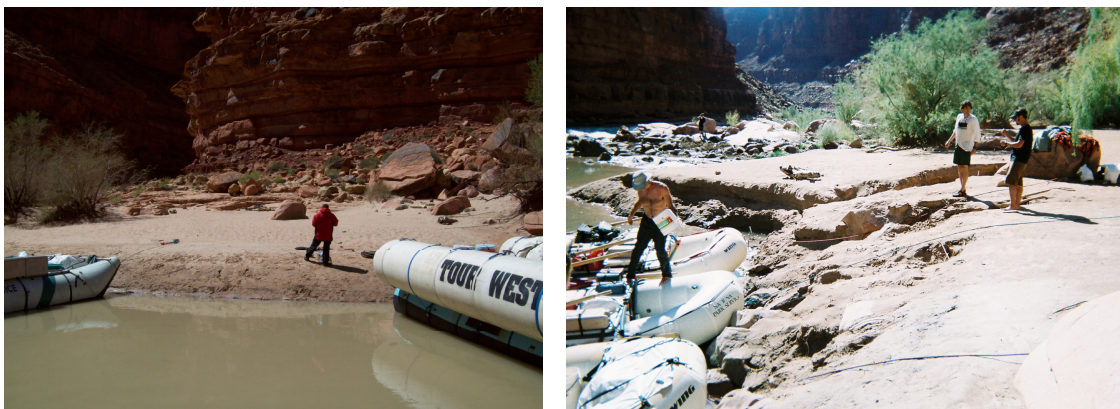
Figures 9 & 10. Upper North Canyon , RM 20.7 R April 2, 2010 (left) and October 17, 2010 (right) documenting a rain erosion event.

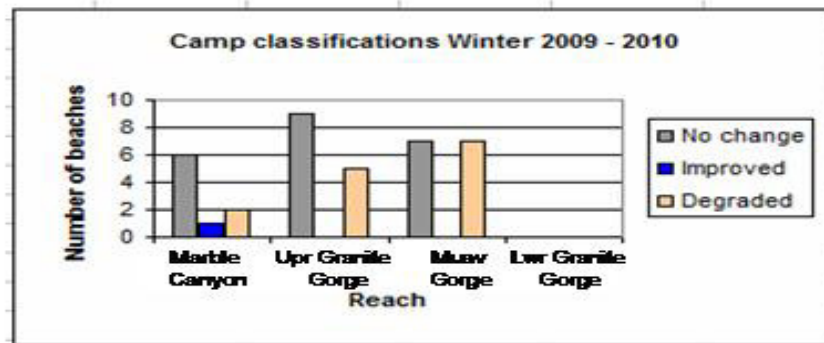
A comparison between the late 2009 and early April 2010 beach conditions was conducted to evaluate possible changes over the winter. Of the 37 beaches considered in this portion of the analysis, 59.5% of the beaches remained unchanged through the winter, 2.7% or one beach, had Improved and 37.8% were classified as Degraded. Of the Unchanged beaches, 16.2% are situated in Marble Canyon, 24.3% in the Upper Granite Gorge and 18.9% are located in the Muav Gorge. The single beach classified as Improved for this time period is the upstream most study beach in Marble Canyon reach and may have benefited from an increase in sediment inflow from the Paria tributary in late January or early February. Degraded beaches were dispersed, with 5.4% located in the Marble Canyon reach, 13.5% in the Upper Granite Gorge and another 18.9% located in the Muav Gorge. None of the beaches from the Lower Granite Gorge were considered in this part of the analysis due to a lack of photographs. Beach front erosion and recession, commonly associated with higher dam releases, were the predominant cause for a Degraded classification, with rain and human impacts sited as secondary factors.

Figure 11. Graphic illustration of results, Winter 2009 - 2010

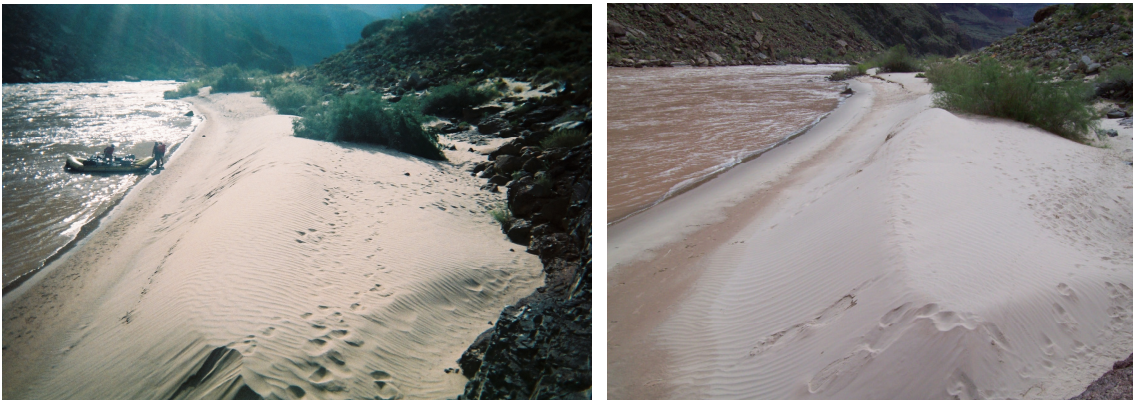
Figures 12 & 13. Owl Eyes beach, RM 135.2 L September 18, 2009 (left) and April 10, 2010 (right).

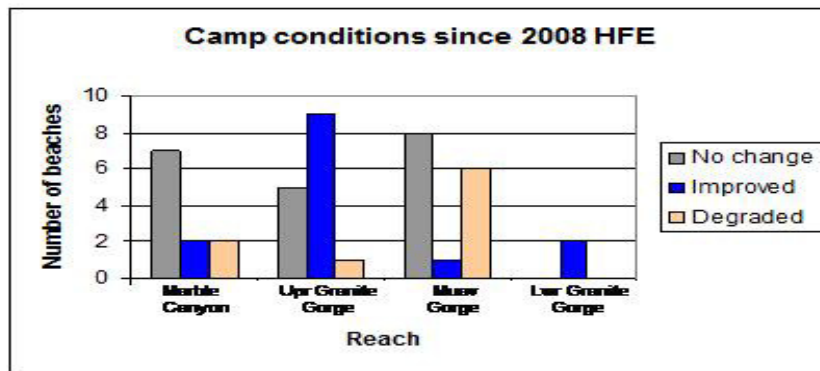
2010 were available for comparison to the late season photographs acquired in 2007 (Lauck, 2009). Of these, 46.5% were considered to be about the Same condition now as in 2007, 32.6% were classified as remaining Improved since the HFE and 20.9% have Degraded beyond their pre-2008 condition. When divided into their respective reaches, 16.3% of the Unchanged beaches are located in Marble Canyon, 11.6% are in the Upper Granite Gorge and 18.6% are in the Muav Gorge reach. None of the Unchanged camps were located in the Lower Granite Gorge. Those beaches considered Degraded are distributed as 4.7% in Marble Canyon, 2.3% or one beach, are located in the Upper Granite Gorge and 14% are found in the Muav Gorge. Again, there are no Degraded beaches located in the Lower Granite Gorge. For beaches classified as remaining Improved due to the HFE event, 4.7% are located in Marble Canyon, 20.9% in the Upper Granite Gorge, a single beach or 2.3%, is in the Muav Gorge and another 4.7% are located in the Lower Granite Gorge. For those beaches rated as Improved when compared to the 2007 images, most had a greater camping area available at the end of 2010. This was usually a combination result of both sand deposition and vegetation removal during the HFE. In one case, however, the vegetation decrease in a camp was the result of beaver activity! The most common cause cited for increased Degradation was sand removal at the beach front by river erosion, followed by erosion from rain events.

It is important to note that a few of the beaches ‘reversed’ in classification through the intervening three years. That is, some of the camps now considered as Improved when compared to the 2007 images were initially regarded as being less desirable following the 2008 HFE. This is predominantly a factor of those beach fronts found to be very steep or rocky immediately following the HFE having graded to a lower angle and extended forward in the subsequent years.

Figure 14. Graphic illustration for beach classifications, late 2010 compared to late 2007.
