# Long-Term Monitoring of Camping Beaches in Grand Canyon

*Summary of Monitoring Observations for Year 2014  
and Overview of Results for 1996 through 2013 High Flow Events*

*By  
Paul Lauck<sup>1</sup>*

*July 7, 2015*

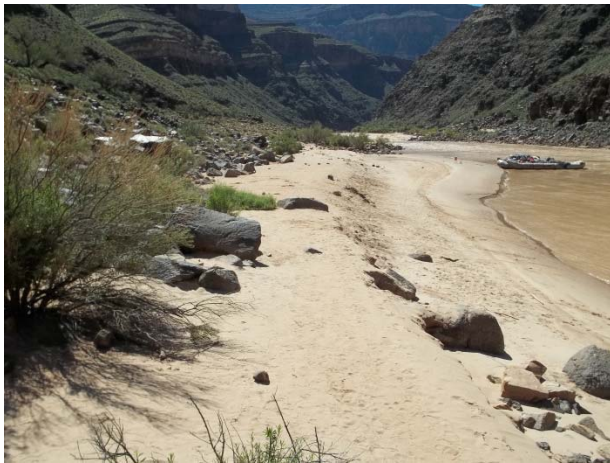
*Stone Creek Camp, RM 132.4 R September 2013*

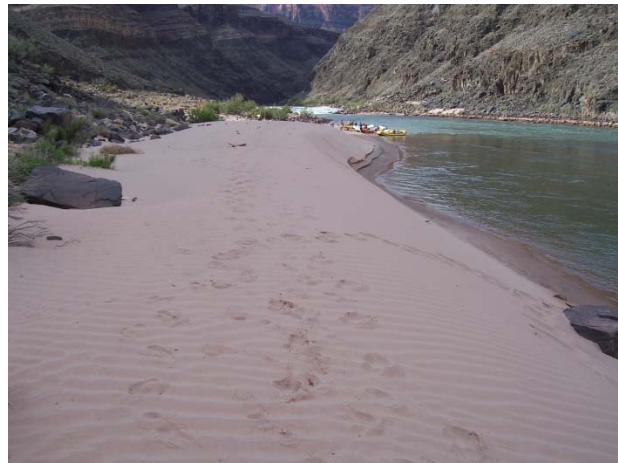
*Stone Creek Camp, RM 132.4 R April 2014*

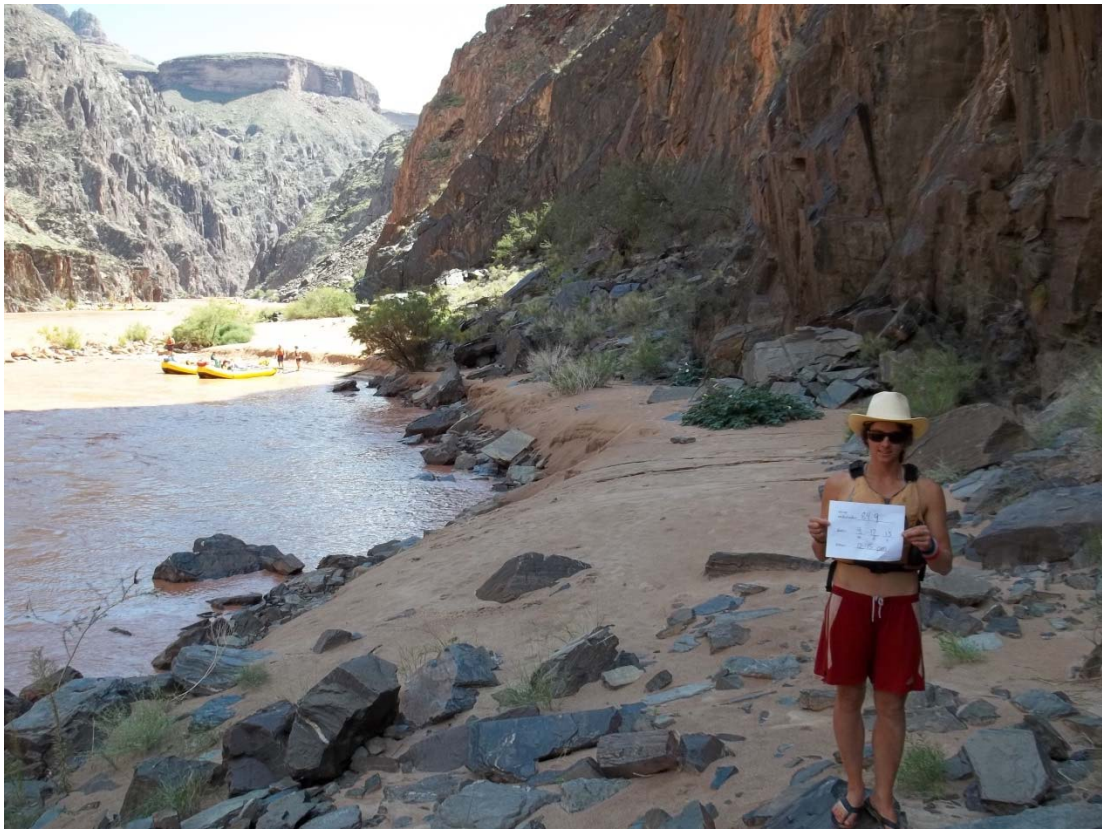
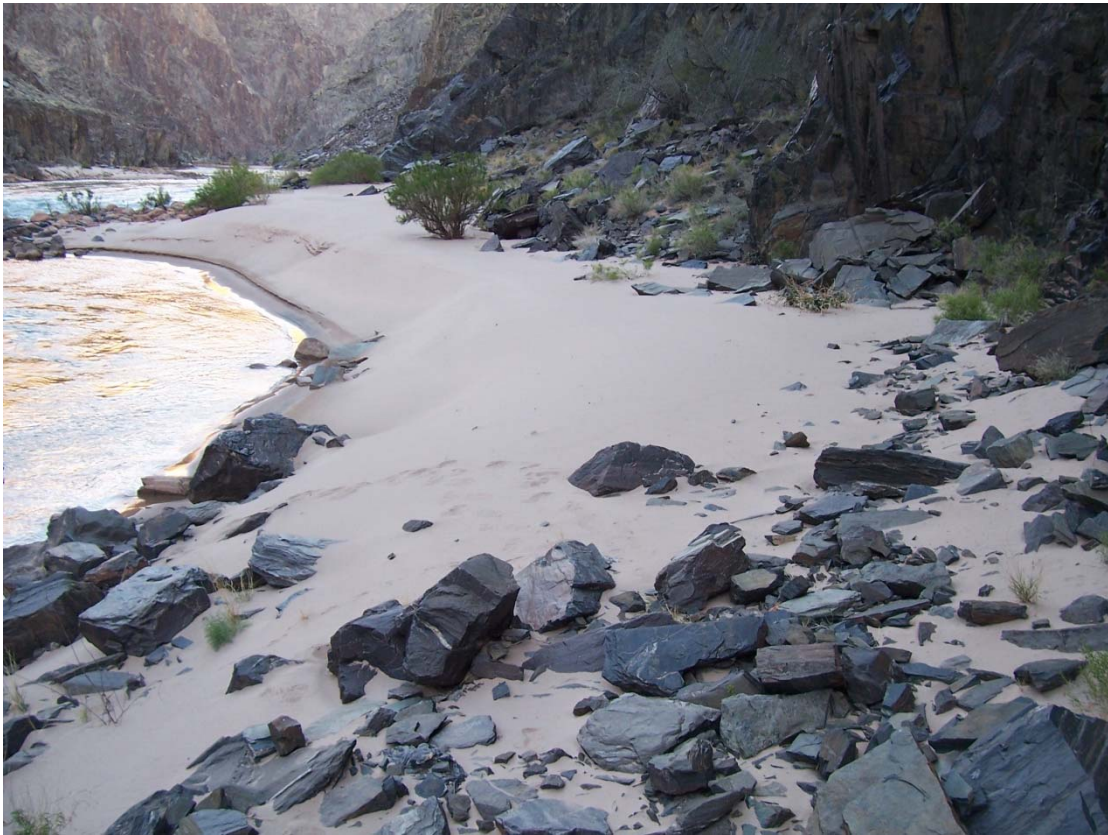
*Figure 2 & 3. Zoroaster Camp, RM 84.9 L, 9/12/2013 (top) and 4/6/214 (bottom)  
Documents an increase in preferred camping area after the 2013 HFE.*

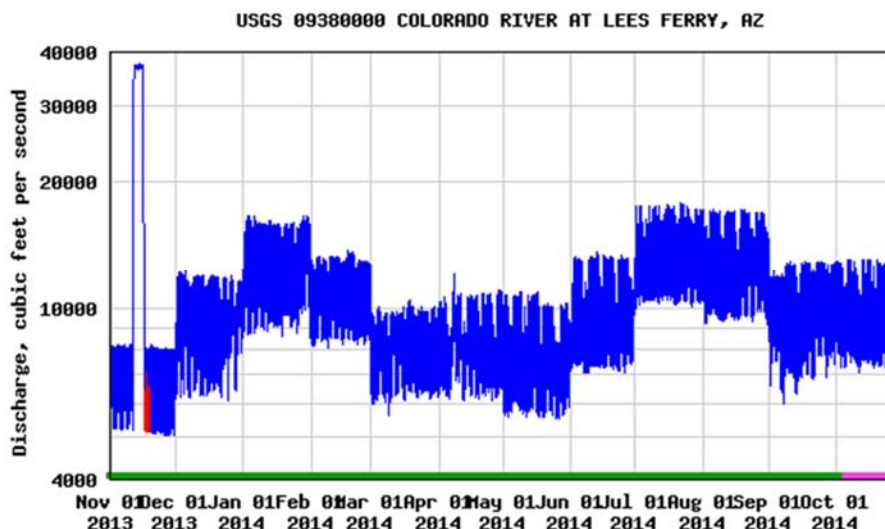
Figure 4. Flow graph for Colorado River at Lees Ferry, AZ., late 2013 through Oct 2014

A High Flow Experiment was conducted in the Grand Canyon in November of 2013 (see Fig. 4). This event complicated the normal analysis of how the winter flow regime and weather factors affected the beaches between October 2013 and April 2014, as photos of the HFE results were not obtained until some months after the fact and after the winter flow regime. So, this evaluation partly addresses both instances.

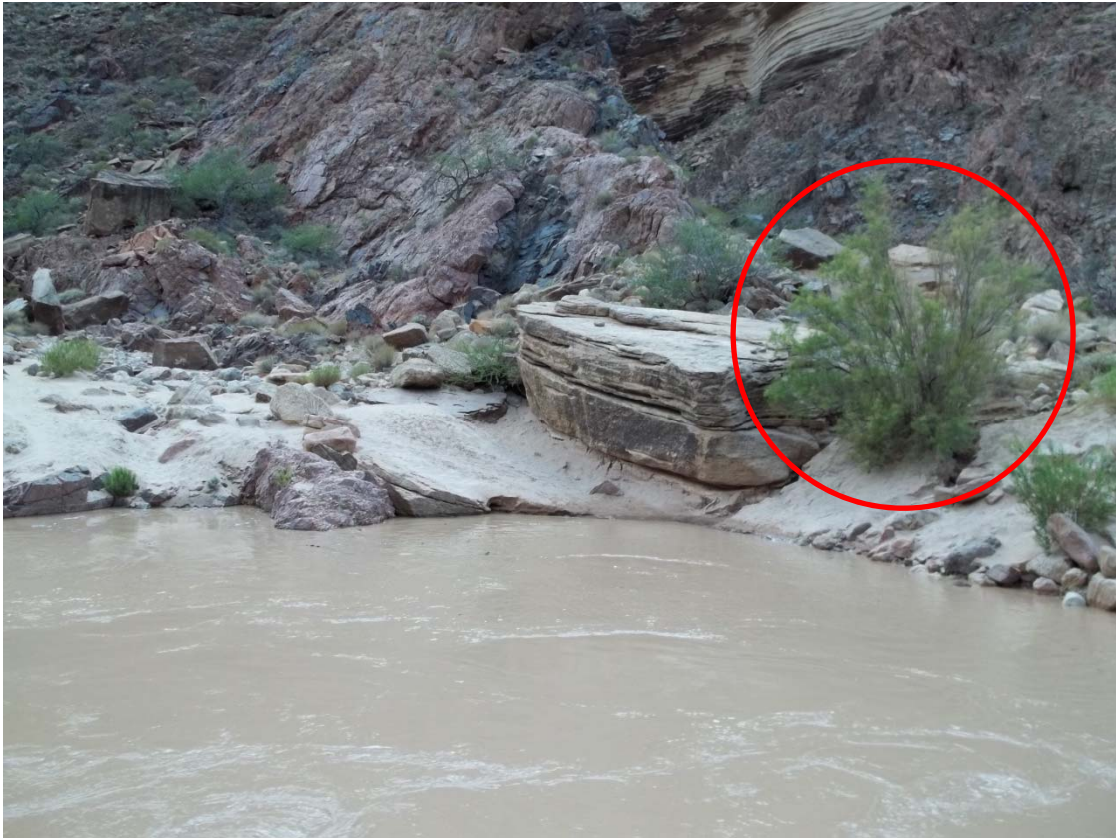
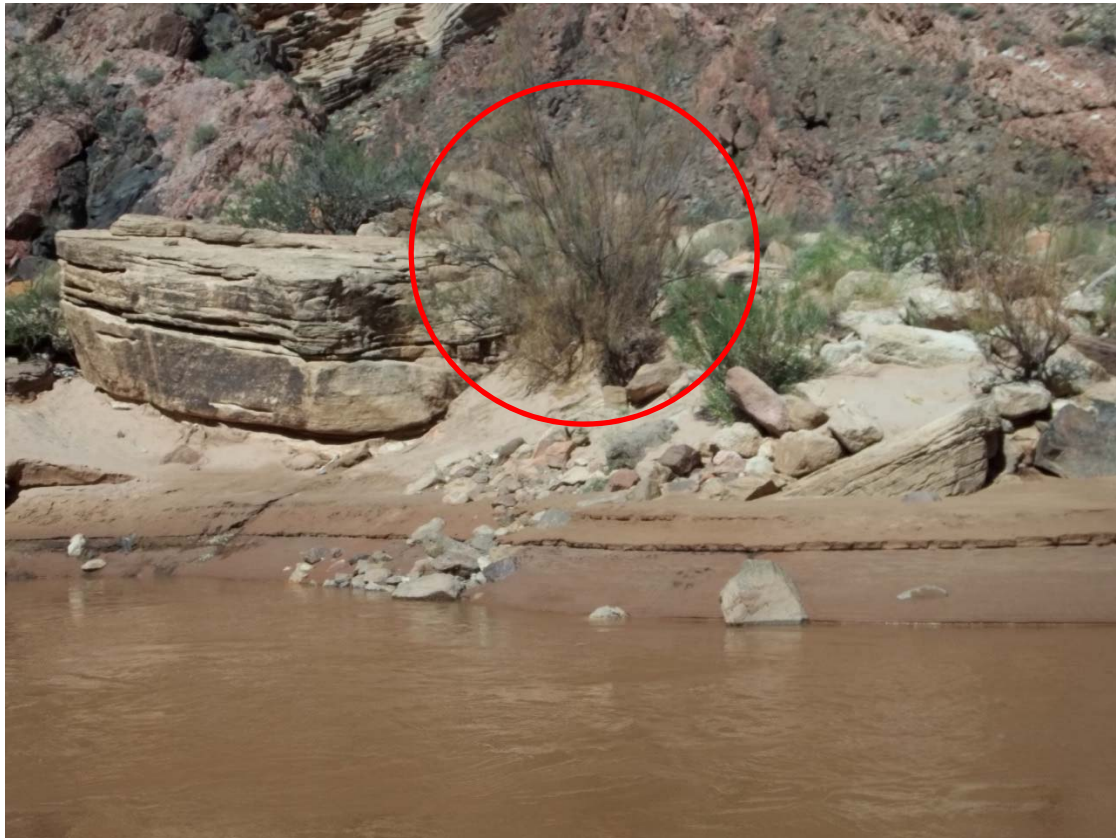
Figures 12 & 13. Upper Garnet Camp, RM 114.5 R. Photo on top taken July 22, 2014 and bottom taken September 10, 2014. Documented defoliation of tamarisk tree.

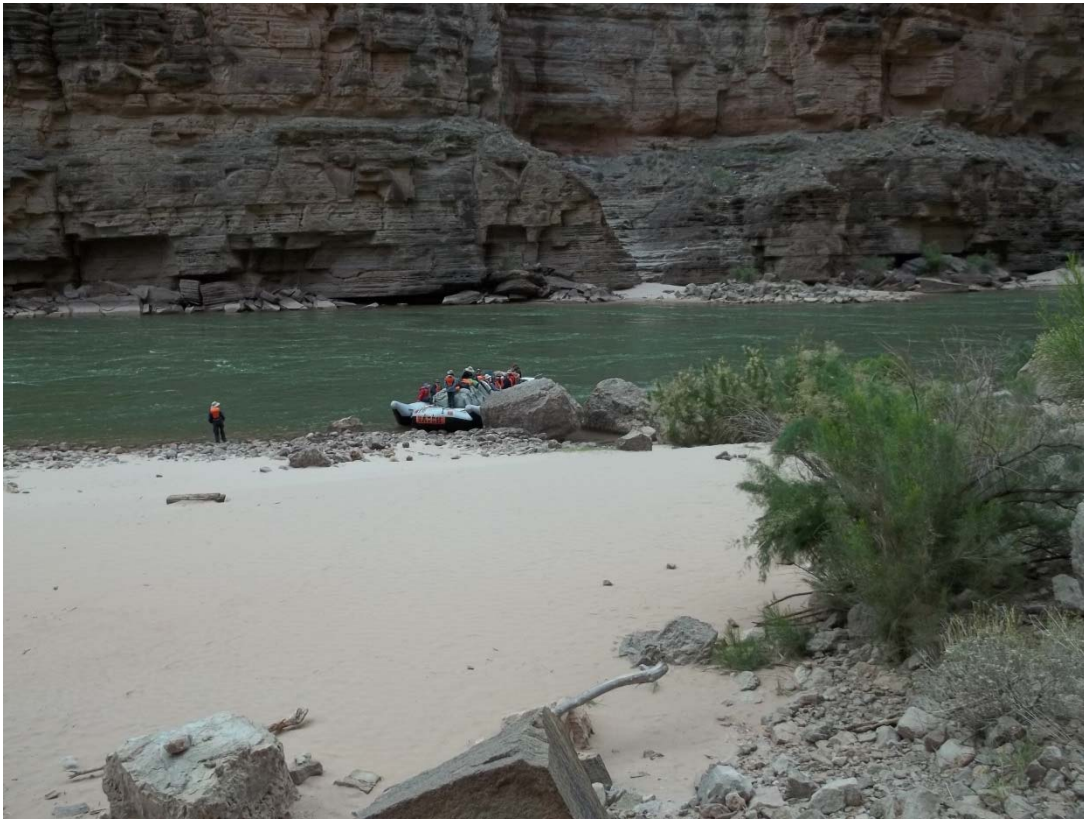
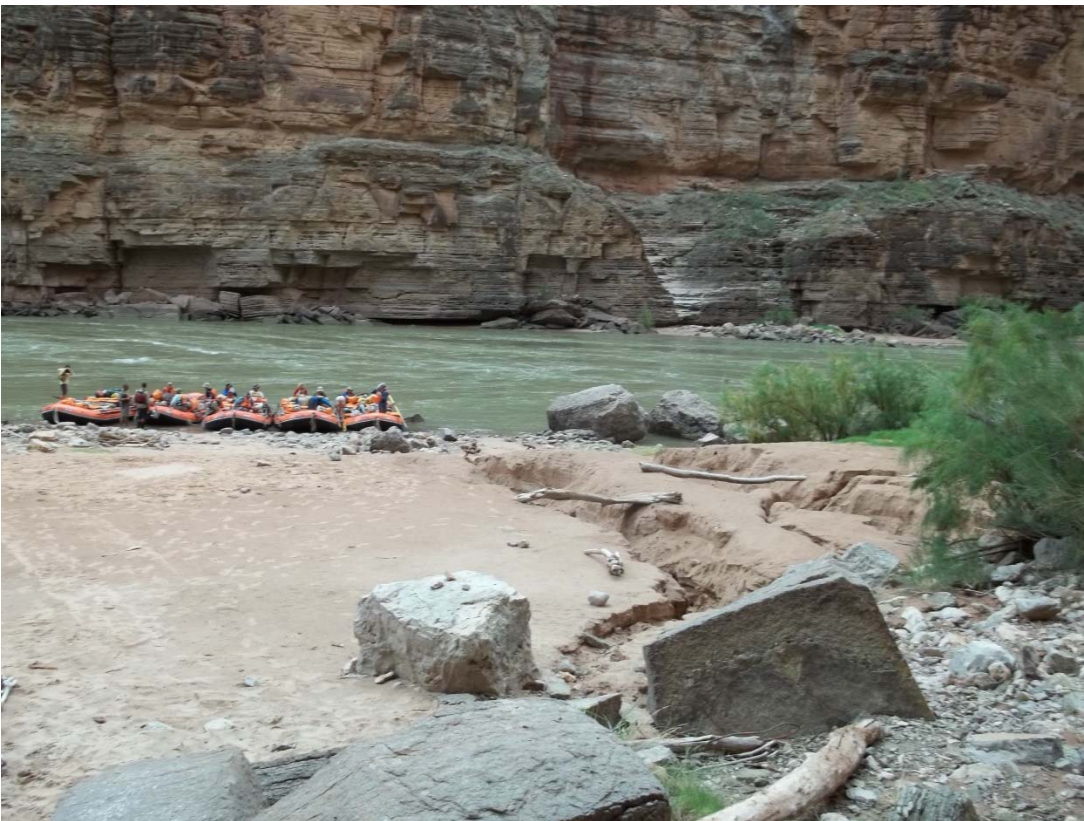
*Figures 14 & 15. Tuckup Canyon Camp, RM 165.1 R May 7, 2014 (top) and September 8, 2014 (bottom). Documented loss of camp area due to rain erosion through beach. Also note lack of evidence of beetles in tamarisk.*

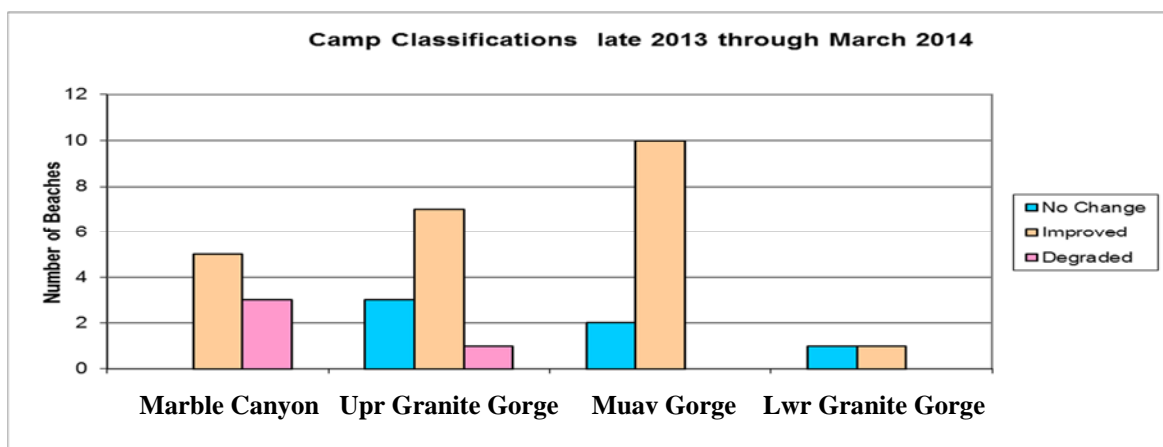
Figure 17. Graphic illustration for pre\_HFE 2013 to Spring 2014 evaluations
