ADOPT-A-BEACH PROGRAM

Long-Term Monitoring of Camping Beaches in Grand Canyon

Summary of Monitoring Observations for Year 2016

By
Paul Lauck¹

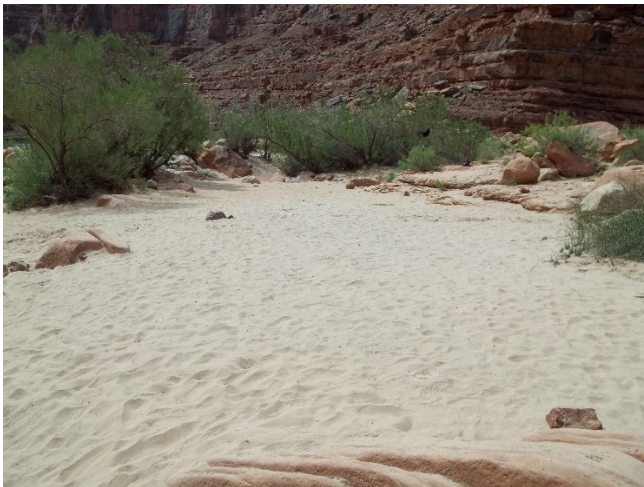
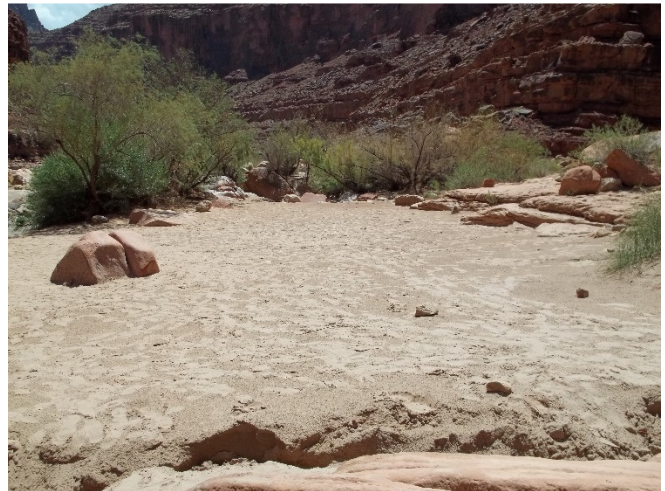
*Example of sand depletion from beach due to wind activity over four month period.
Upper North Canyon Camp, RM 20.7 R. Photo on left taken April 4, 2016 and photo on right taken August 6, 2016.*

The same kind of visual clues can also be used to determine aeolian action, particularly when the exposed and/or covered rocks and shelves are higher than any possible river flow level during the time period being examined. During the November 2014 HFE, some camp areas increased as a result of boulders and bedrock being covered by sand carried onto the beach at the higher flow. Since then, some of these rocks have re-emerged as a result of wind scour, resulting in a decrease in camp area. The Upper North Canyon Camp is an excellent example of this action (See cover page).

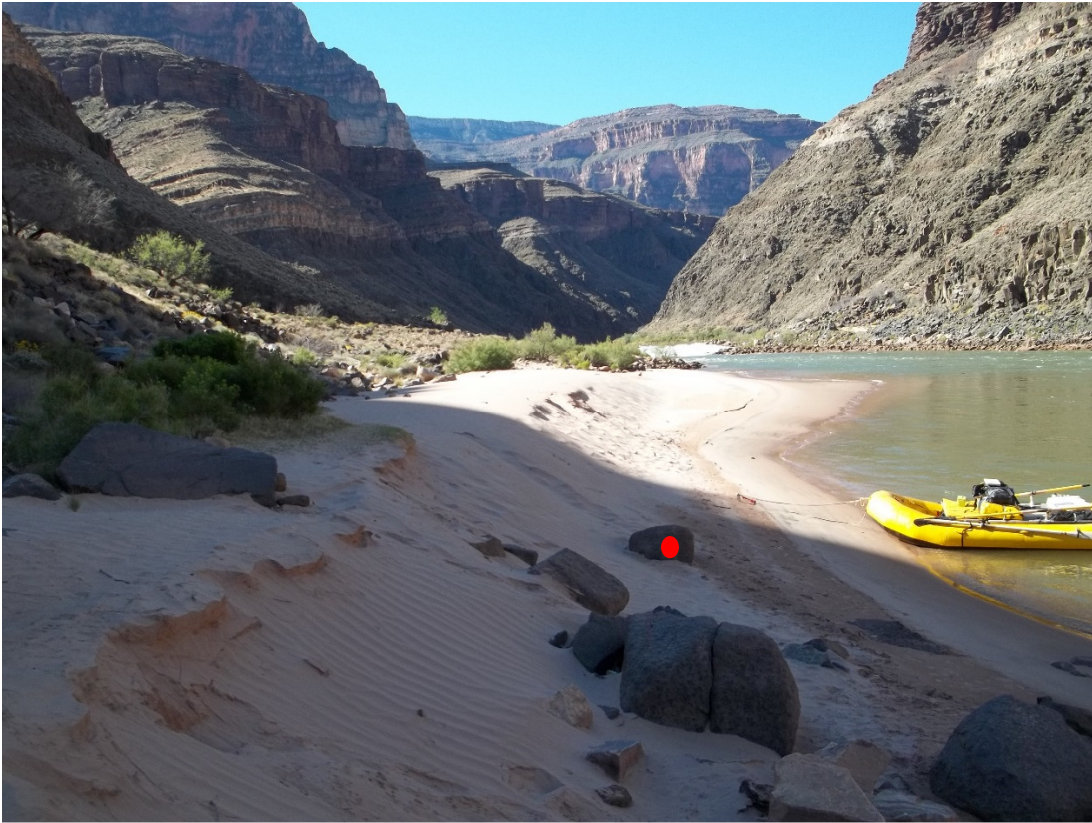
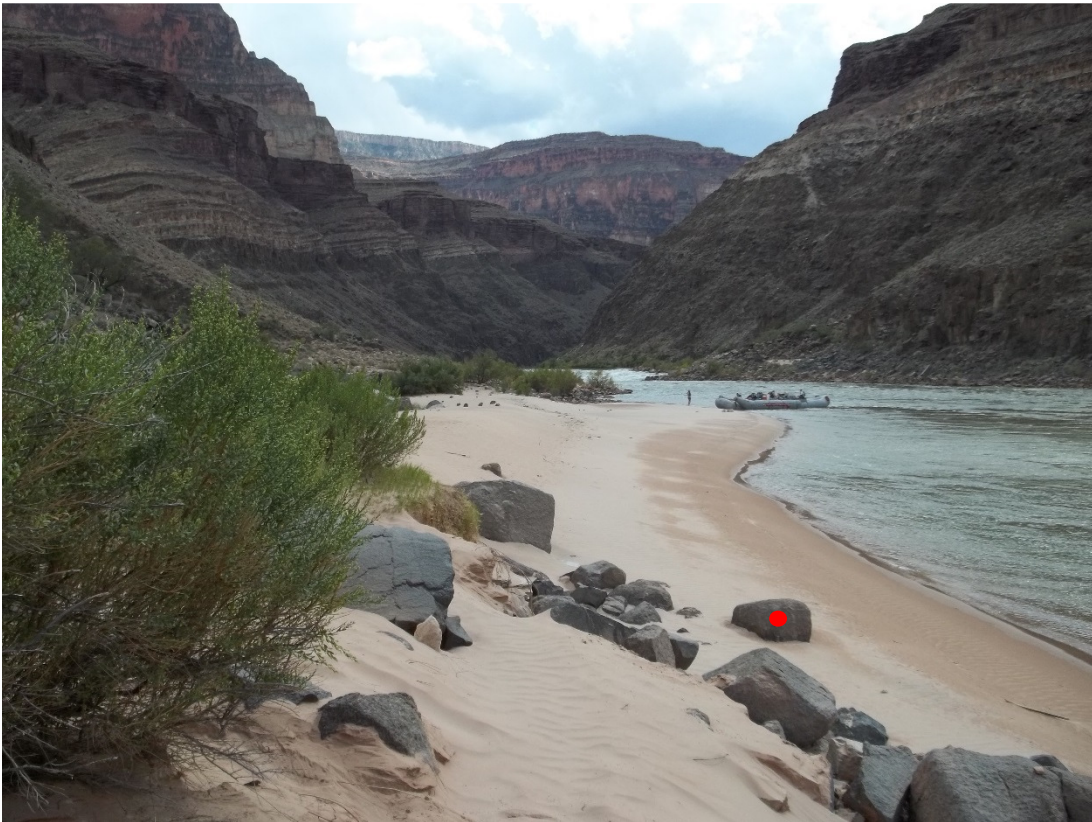
Figure 2 & 3. Example of beach with fluctuating flow recession and rock exposure. Stone Creek Camp, RM 132.5 R, April 12, 2016 (top) and September 13, 2016 (bottom). Red dot identifies reference rock.

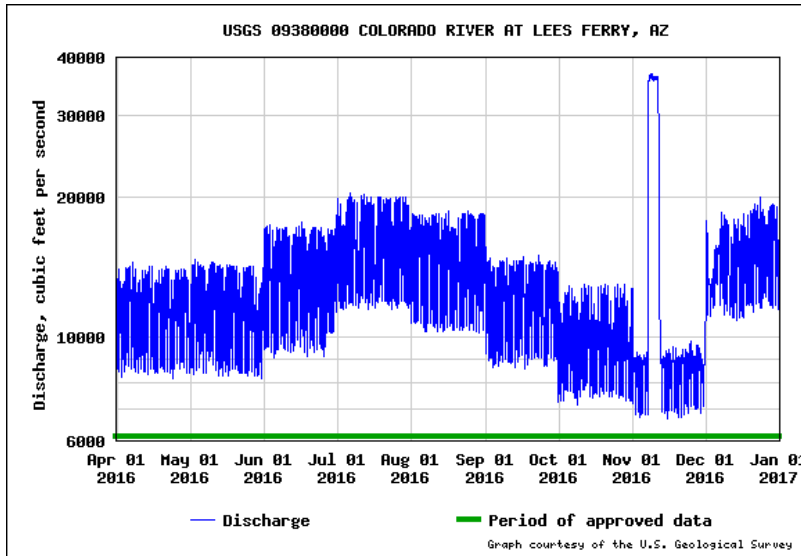
Figure 4. Flow graph for Colorado River at Lees Ferry, AZ., April 1 through Dec 31, 2016

For the period covering the 2016 summer boating season, photos were used which spanned from April 4 to November 8. The highest release flows during the season started July 1, maximized at near 20,000 cubic feet second and continued through that month. Weekday daily flow fluctuations were consistently near 8000 cubic feet second (cfs) through the 2016 season, with weekend fluctuations slightly lower. Release flows were consistent at 8000 to 14000 cfs during March through May, stepped up 4000 cfs for the month of June, and another 2000 cfs through July. The releases were lowered by 2000 cfs for the month of August, 4000 cfs through September and yet again by 2000 cfs for the month of October. In order to include this factor in the analysis, the earliest season ending date considered was July 31 with three exceptions. Those dates are in mid-July and were only included because factors were already evident indicating significant change had occurred to the beach. A large percentage of the ending dates fall between mid-September and mid-October. Forty-three of the 44 beaches were adopted for the 2016 season with 39 having photographs and photographer comment sheets spanning a sufficient period of time to be evaluated. Four were not photographed late enough in the season to be considered for a complete season analysis and one had a photo set that began late in the summer, so it was not evaluated. Of the 39 beaches included in this portion of the analysis, 17 (44%) did not show significant changes, and were classified as Unchanged through the season. Twenty-one of the beaches (54%) had Degraded through the summer, and one (3%) of the beaches evaluated was considered Improved by the Fall of 2016. This was the beach at Buck Farm Canyon, RM 41.2 R and, although photographic evidence indicated a possible Degradation of the beach due to recession, the commenter stated that parking had Improved at lower river levels towards the end of the summer.

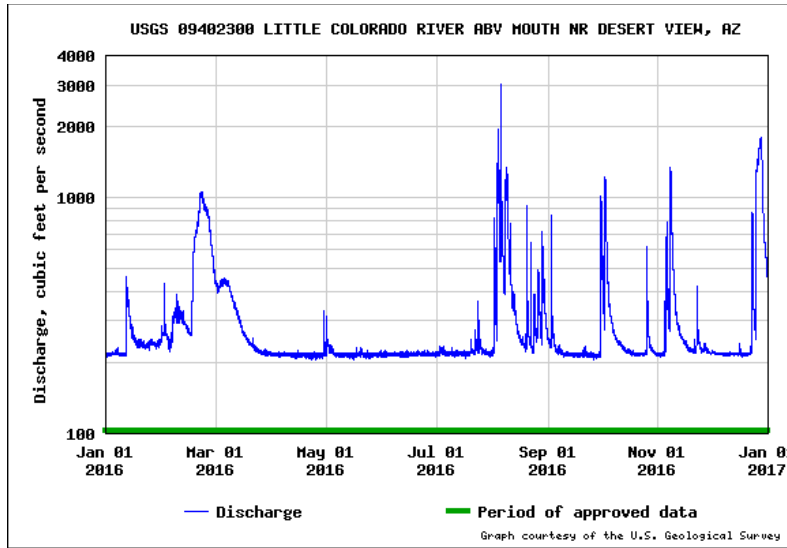
Figure 7. Flow graph for Little Colorado River above mouth near Desert View, AZ., January 1 through December 31, 2016

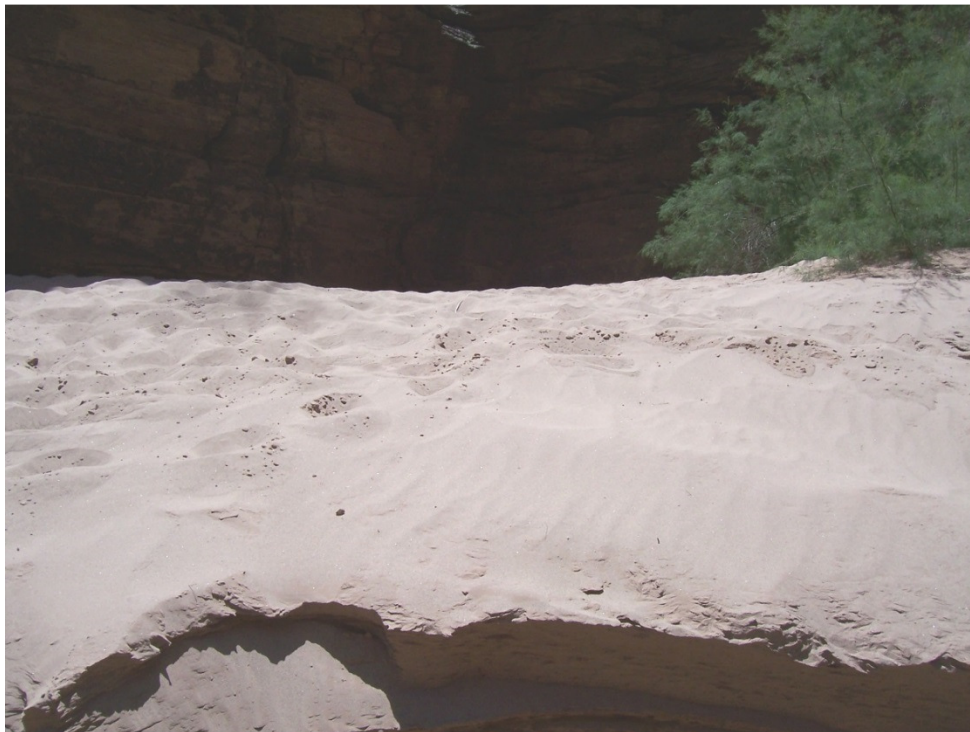
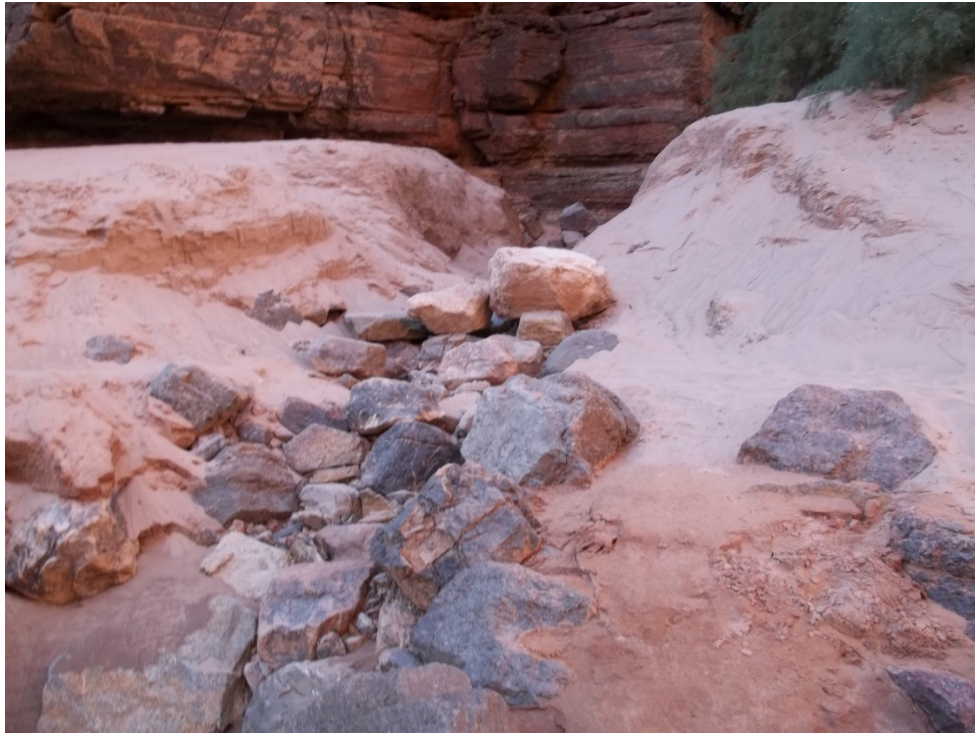
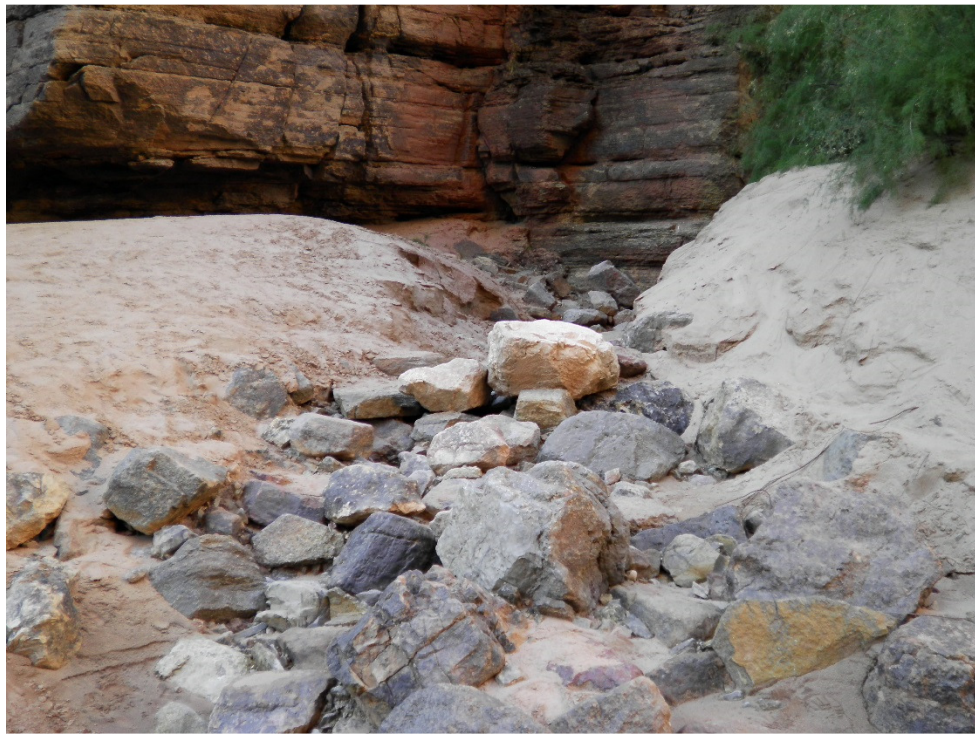
Figures 11, 12 & 13. Documentation of continued degradation of camp area due to rain erosion through beach. Matkatamiba Camp, RM 148.9 L April 11, 2015 (top) and October 8, 2015 (middle) and October 4, 2016 lower).

Olo	146.1 L			X	Sand loss at parking, rocks exposed
Matkat Hotel	148.9 L			X	Rain erosion increased, new gullies, some sand loss
Upset Hotel	150.9 L	X			No change observed
Last Chance	156.3 R	X			No change, limited data available to compare
Tuckup	165.2 R				No late season 2016
Upper National	167 L			X	Sand loss at parking, more veg in camp
Lower National	167.2 L	X			Almost exactly same
Total per Reach	15	5	0	9	
Travertine Falls	230.6 L			X	Recession at upper end
Gneiss	236.1 R				No late season 2016
250 Mile	250.0 R			X	Another debris flow covers lower camp area
Total per Reach	3	0	0	2	
Totals	39/44	17	1	21

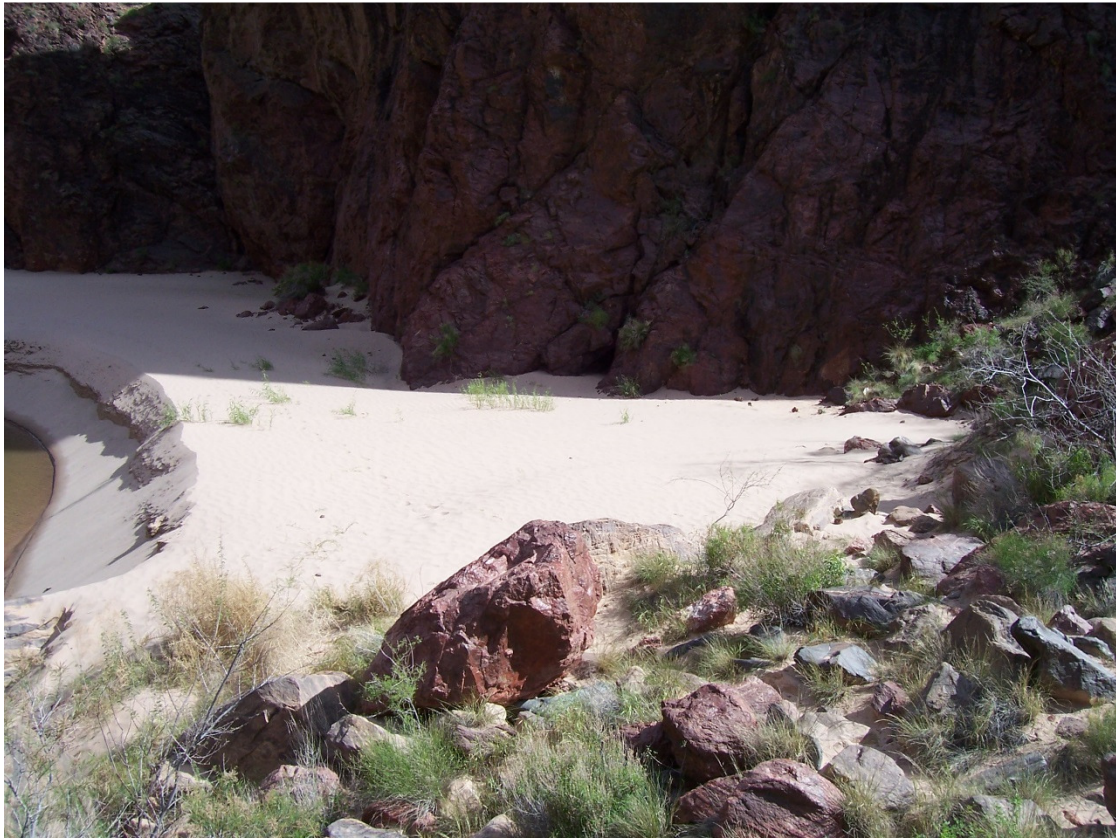
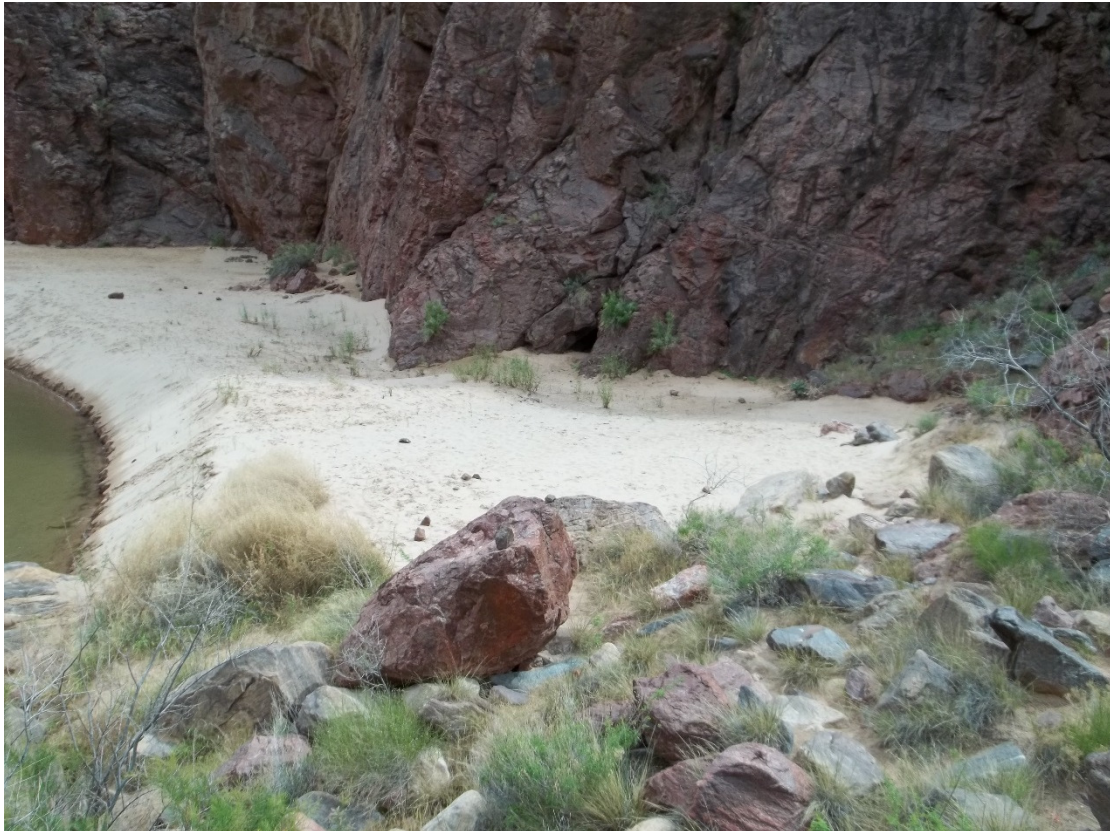
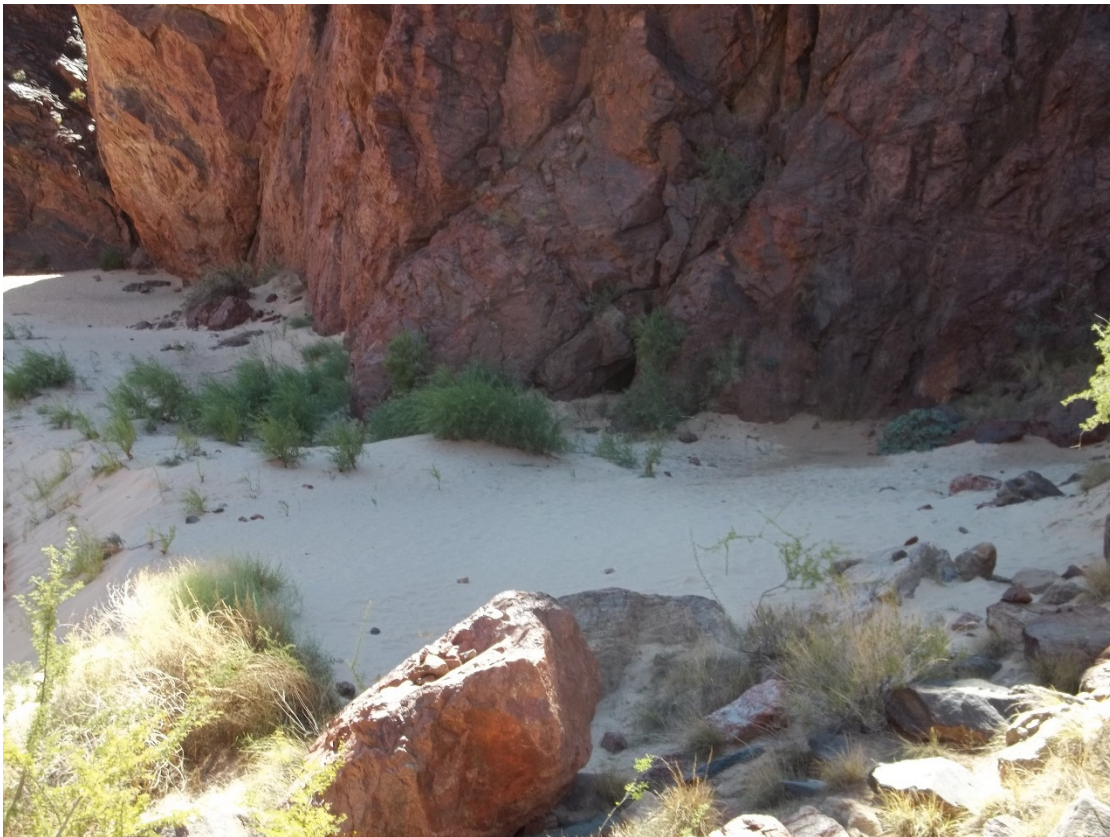
*Figures 15, 16 & 17 Resurgence and proliferation of willows following the November 2014 HFE.
Photo dates: April 6, 2015 (top), April 9, 2016 (middle) and September 25, 2016 (bottom).
Grapevine Camp RM 81.7 L*
