# Long Term Monitoring of Camping Beaches In Grand Canyon

*Summary of Results for 2012 with  
Comparisons to Observations of the 1996 Beach Building/Habitat Flow*

*Annual Report of Repeat Photography  
By Grand Canyon River Guides, Inc.<sup>1</sup>  
(Adopt-A-Beach Program)*

*By  
Paul Lauck<sup>2</sup>  
June 12, 2012*

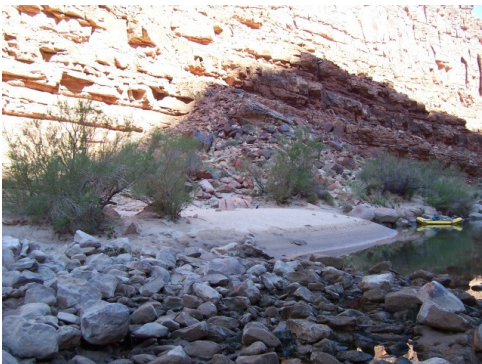
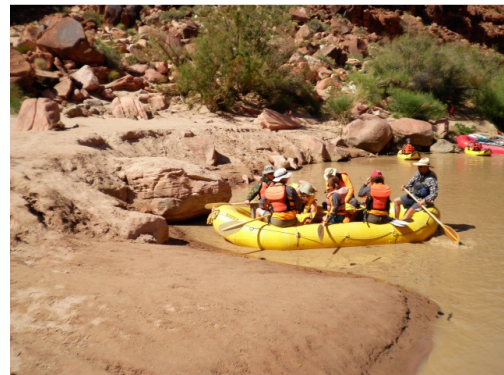
*Upper North Canyon Camp, RM 20.7 R, 4/3/12 (left) and 9/13/12 (right)  
Documents erosion across beach front after summer fluctuating flows.*

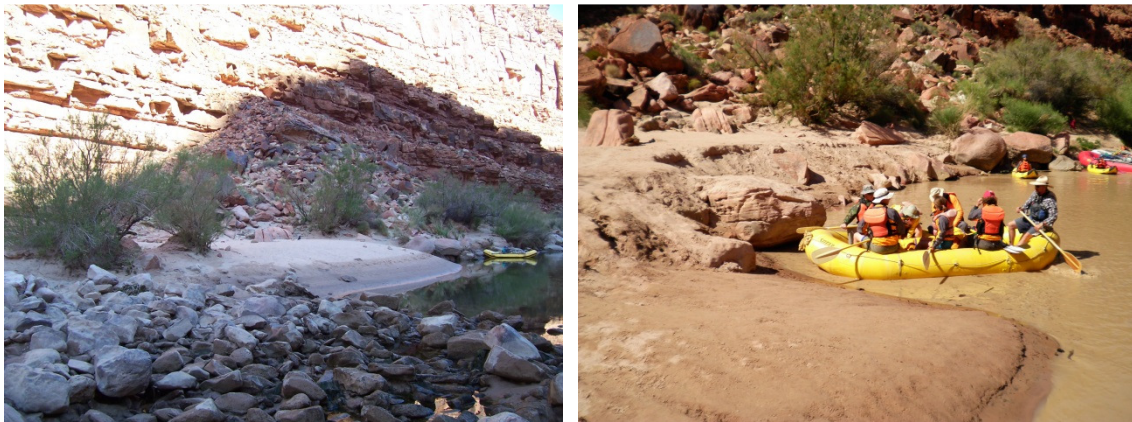
*Figure 2 & 3. Upper North Canyon Camp, RM 20.7 R, 4/3/12 (left) and 9/13/12 (right)  
Documents erosion across beach front after summer fluctuating flows.*

19.4 Mile	19.4 L			X	Slight degradation - late season erosion
Upper North Canyon	20.7 R			X	Beach recession, cutbank, aeolian depletion
23 Mile	22.7 L				No late season photos
Shinumo Wash	29.5 L			X	Sand loss along front, more rocks visible
Nautaloid	35 L		X		Slightly better for parking/off loading
Tatahatso	37.9 L	X			Guide says same, no late season photo
Martha's	38.6 L			X *	More rocks in parking area ( * Late July eval date)
Buck Farm	41.2 R			X	Lots of sand loss, though front slope decreased
<i>Total above</i>	11	1	2	5	
Nevills	76 L				No late season photos
Hance	77.1 L				No late season photos
Grapevine	81.7 L	X *			( * Late August evaluation date)
Clear Creek	84.6 R	X			Slight veg increase
Zoroaster	85 L				No late season photos
Trinity Creek	92.1 R			X	Increase in drainage gully size
Schist	96.6 R			X	Sand recession, more rocks at beach front
Boucher	97.3 L				No late season photos
Crystal	98.7 R	X			No change evident

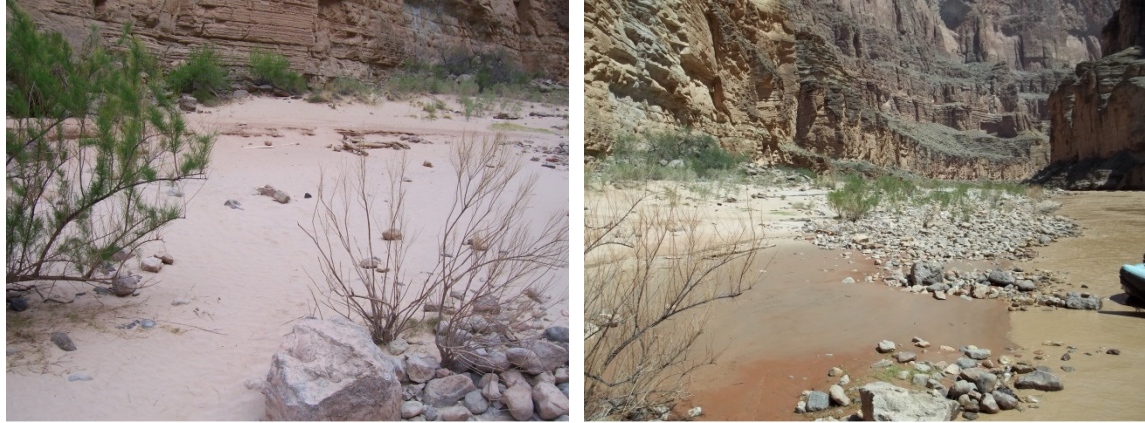
Figure 4 & 5. Tuckup Canyon, RM 165.2 R. Photo on left taken 4/13/12, right taken 8/25/12. Documented defoliation of tamarisk tree.

Last Chance	156.3 R				No late season photos
Tuckup	165.2 R			X	Rain gully, cutbank, tummy beetle noted
Upper National	167 L			X	Loss of camp from flash flood
Lower National	167.2 L		X *		* Old camp removed by flash, new camp is bigger!
<i>Total above</i>	15	3	2	7	
Travertine Falls	230.6 L				No late season photos
Gneiss	236.1 R			X *	Lots of beach loss ( * Early August eval date)
250 Mile	250.0 R			X	Rain gully through lower camp area
<i>Total above</i>	3	0	0	2	
<b>Totals</b>	<b>44</b>	<b>10</b>	<b>5</b>	<b>17</b>	
Reported	32				
% of beaches	73	31.3	15.6	53.1

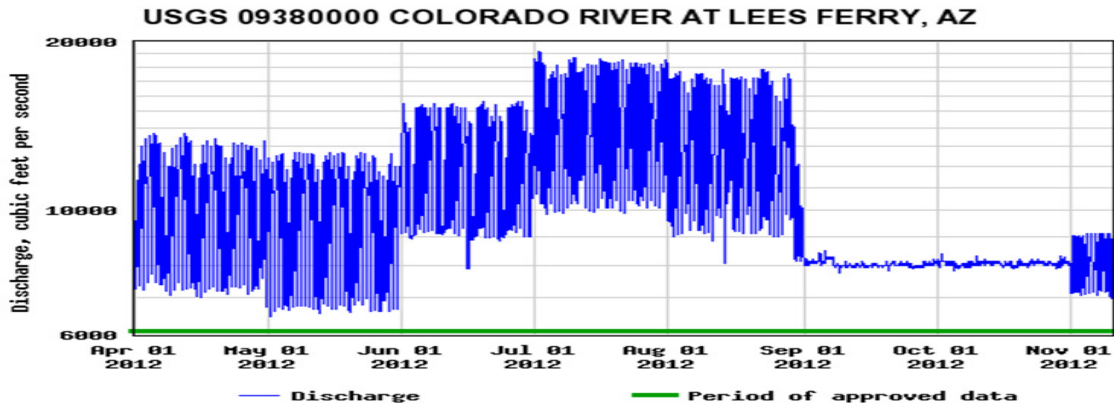
Figure 6. Flow graph for Colorado River at Lees Ferry, AZ., season of 2012

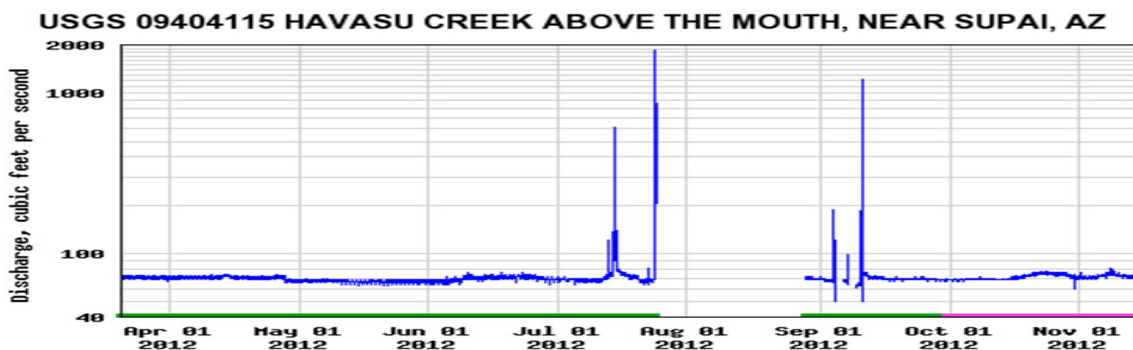
Figure 11. Flow graph for Havasu Creek above the mouth near Supai, AZ., 2012

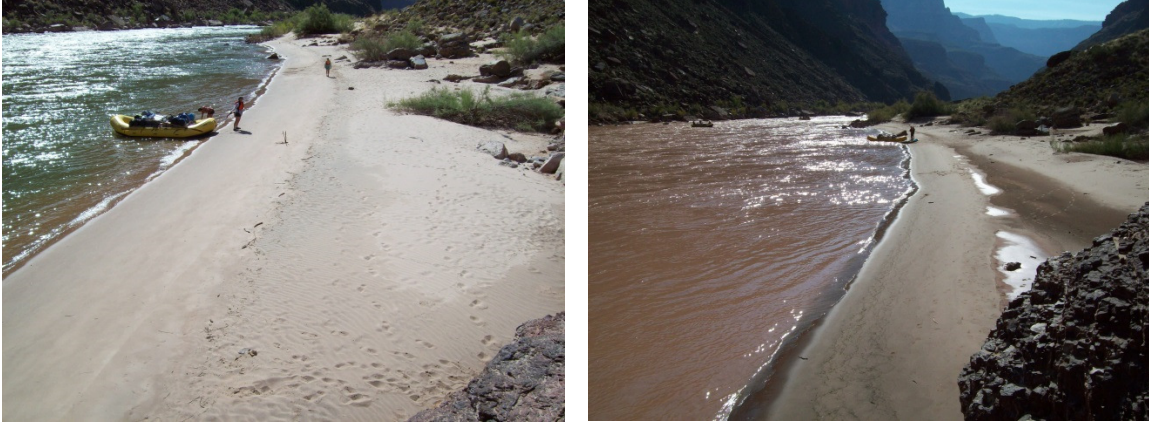
Figures 12 & 13. Owl Eyes Camp, RM 135.2 L June 3, 2012 (left) and September 21, 2012 (right)  
 A beach that was nearly the same from early in the season and again when the flows declined.

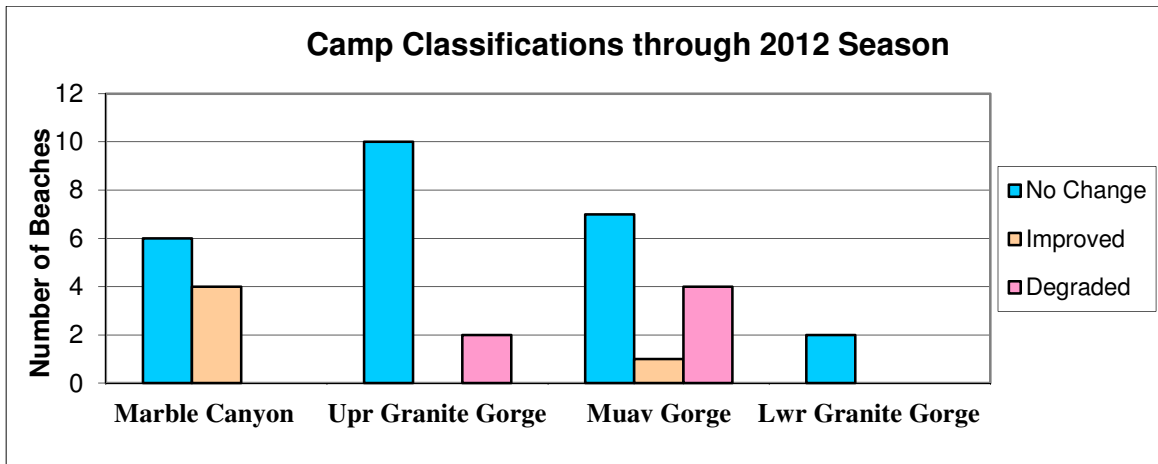
Figure 14. Graphic illustration for 2012 seasonal evaluations

For the time spanning the 2012 summer boating season, early April to early September, 32 of the 44 study beaches in the program had photographs and photographer comment sheets spanning a sufficient period of time to be evaluated. Only three of the beaches were orphaned after the initial April photo set, but 9 were not recorded late enough to be considered for a complete season. The change of the flow regime beginning in early September was chosen as the optimal time to conclude the season for evaluation, but evidence of change was included if noted in mid-late August. Of these 32 beaches, 31% were classified as Unchanged for the time period, 16% had Improved through the summer and 53% were considered as Degraded by the end of the season. Of the Unchanged beaches, 10, or 31% were located in the Marble Canyon reach, 60% in the Upper Granite Gorge reach, another 9% are contained in the Muav Gorge reach and none were located in the Lower Granite Gorge. Forty percent of the Improved beaches are located in the Marble Canyon reach, another 20% in the Upper Granite Gorge and the remaining 40% are found in the Muav Gorge reach. Neither of the two beaches located in the Lower Granite Gorge included in the study this year was considered to have improved. For the beaches classified as Degraded for this time period, 29% are from the Marble Canyon reach, 18% are found in the Upper Granite Gorge, 41% in the Muav Gorge reach and two, or 12% were located in the Lower Granite Gorge reach.

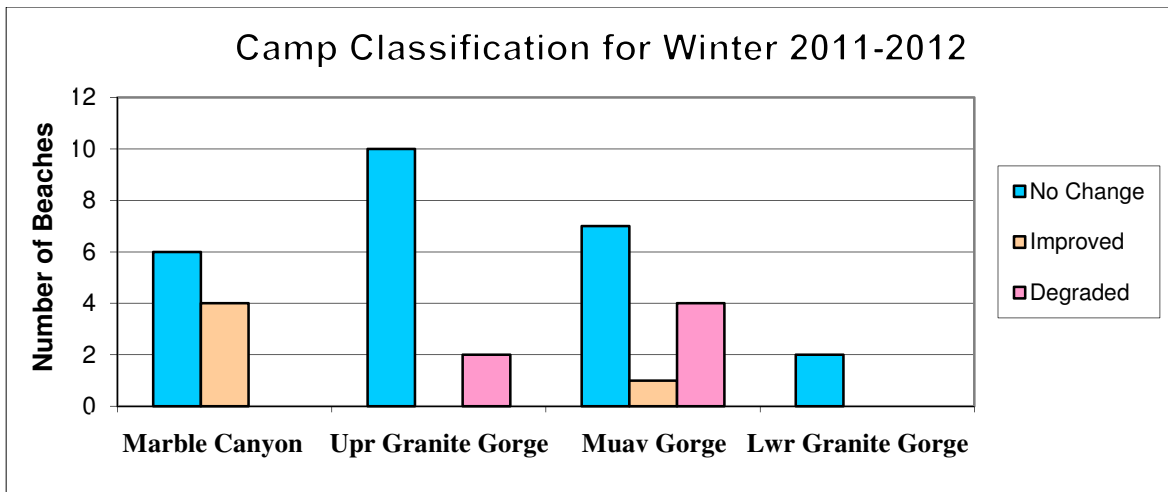
Figure 15. Graphic illustration for winter 2011-2012 seasonal evaluations

Of these 36 camps, 69% did not show enough change to warrant a classification other than Same. Of these, 17% are located in the Marble Canyon reach, 28% are found in the upper Granite Gorge reach and 19% in the Muav Gorge reach. There were two beaches in the Lower Granite Gorge reach rated as Same or 5%.

Only 14% of the beaches considered showed an Improvement in camping condition at the end of the winter. This accounted for 5 beaches, 4 in the Marble Canyon reach and 1 in the Muav Gorge. In general the camps improved due to sand deposition along the beach fronts and because previously steep, cutbank associated parking areas slumped to decrease the slope and improve access. Seventeen percent of the camps evaluated were classified as having been degraded during the winter months. The camps were divided between two reaches, with 2 located in Upper Granite Gorge and 4 in the Muav Gorge. The universal factor cited as evidence for this classification was sand loss across the beach front, with the accompanying cutbanks and exposed rocks.
