Adopt – A – Beach:

Long-Term Monitoring of Camping Beaches in Grand Canyon

Summary of Monitoring Observations for Year 2013

By Paul Lauck¹

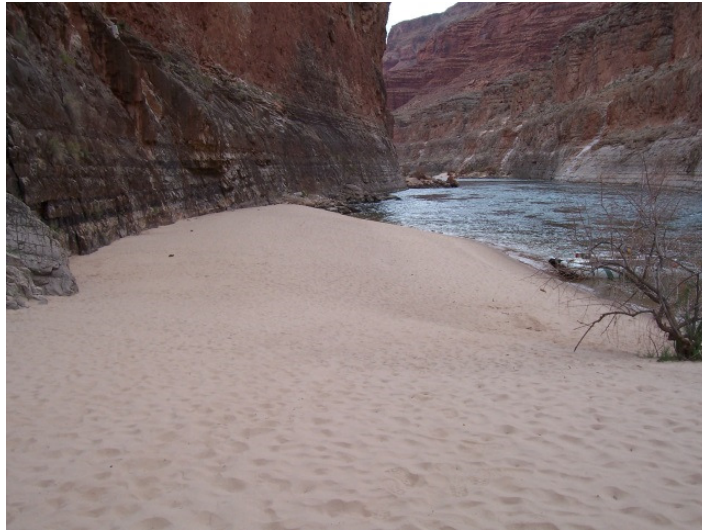
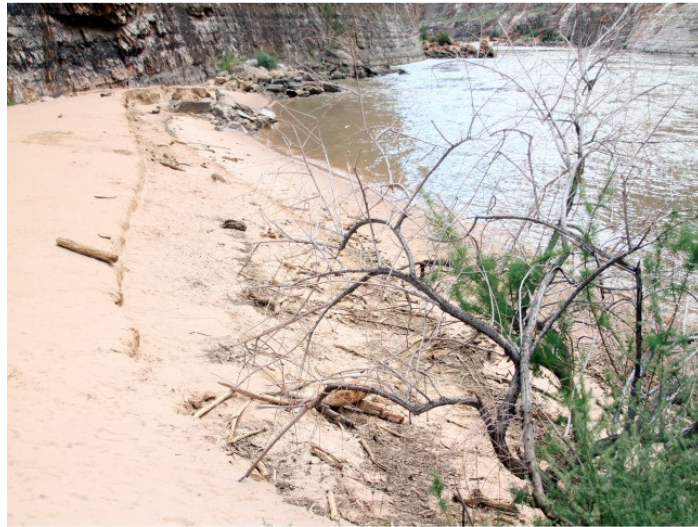
*Figure 2 & 3. Shinumo Wash Camp, RM 29.5 L, 4/2/13 (top) and 9/21/13 (bottom)
Documents erosion across beach front after summer fluctuating flows.*

19.4 Mile	19.4 L			X	Receding shore from fluctuating flows
Upper North Canyon	20.7 R			X	Wind activity very evident
23 Mile	22.7 L			X	Rain erosion, some recession from fluc flow
Shinumo Wash	29.5 L			X	Huge cutbank and recession from fluc flow
Nautaloid	35 L	X			Sand recession and deposition equalized
Tatahatso	37.9 L	X			Identical except slight veg increase
Martha's	38.6 L	X			Minimal change
Buck Farm	41.2 R			X	Shoreline recession from fluc flow and wind loss
<i>Total above</i>	11	4	0	6	
Nevills	76 L			X	Shoreline recession from fluc flow and wind loss
Hance	77.1 L				No late season photos
Grapevine	81.7 L	X			Wind loss noted, but no degradation
Clear Creek	84.6 R			X	Shoreline recession from fluc flow and veg increase
Zoroaster	85 L			X	Huge beach recession from fluc flow, rain and wind
Trinity Creek	92.1 R			X	Lots of wind loss, rain erosion/debris deposit
Schist	96.6 R			X	Rain gully erosion
Boucher	97.3 L	X			Slight loss across front and wind action

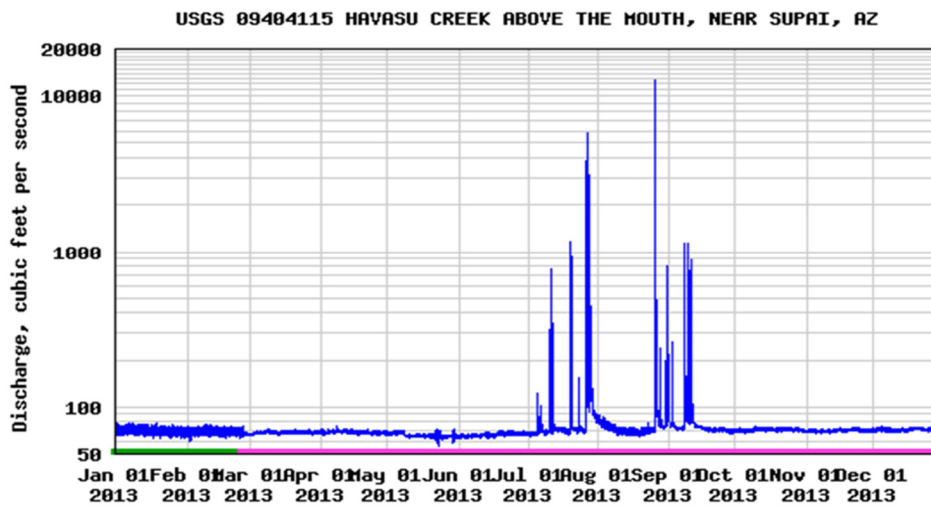
Figure 8. Flow graph for Havasu Creek above the mouth near Supai, AZ., 2013

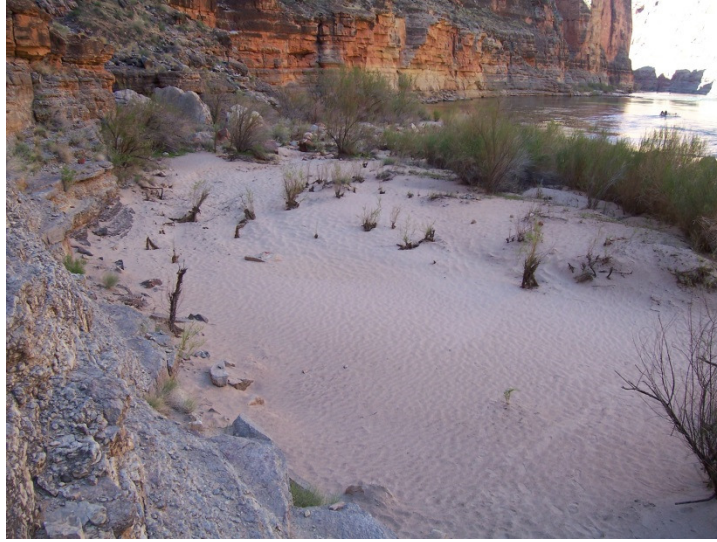
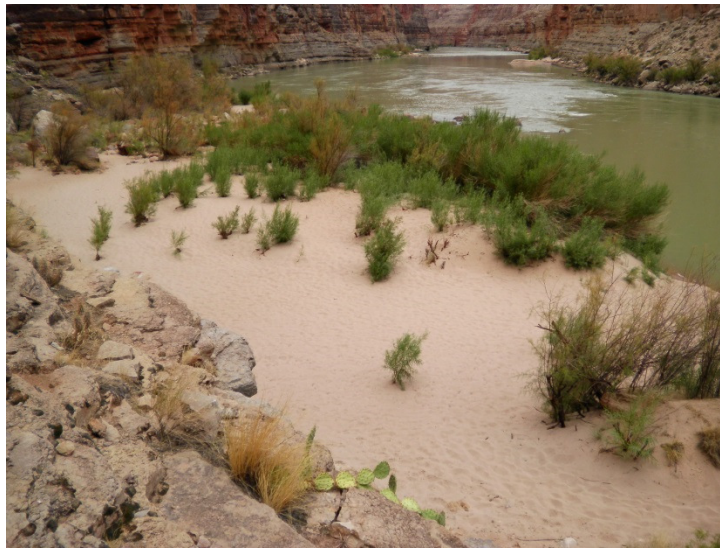
Figures 10 & 11. Tatahatso Camp, RM 37.9 L. Photo on top taken April 2, 2013 and bottom taken July 11, 2013. Documented defoliation of tamarisk tree.

19.4 Mile	19.4 L	X		Yes, cycle evident
Upper North Canyon	20.7 R			??
23 Mile	22.7 L	X		Yes, defoliation
Shinumo Wash	29.5 L			??
Nautaloid	35 L	X		Yes, cycle evident
Tatahatso	37.9 L	X		Yes, defoliation
Martha's	38.6 L			??
Buck Farm	41.2 R	X		Yes, cycle evident
<i>Total above</i>	11	6	0	
Nevills	76 L	X		Yes, defoliation
Hance	77.1 L			??
Grapevine	81.7 L			No tamarisk nearby
Clear Creek	84.6 R		X	No evidence found
Zoroaster	85 L		X	No evidence found
Trinity Creek	92.1 R		X	No evidence found
Schist	96.6 R		X	No evidence found
Boucher	97.3 L		X	No, tammies blooming!
Crystal	98.7 R			??
Lower Tuna	100.2 L		X	No evidence found
Ross Wheeler	108.3 L			??
Bass	109 R			??
110 mile	110 R			??
Upper Garnet	114.9 R		X	No evidence found
Lower Garnet	115.1 R			??
<i>Total above</i>	15	1	7	
Below Bedrock	131.7 R	X		Yes, defoliation
Stone Creek	132.5 R		X	No evidence found
Talking Heads	133.7 L		X	No evidence found
Racetrack	134.2 R		X	No evidence found

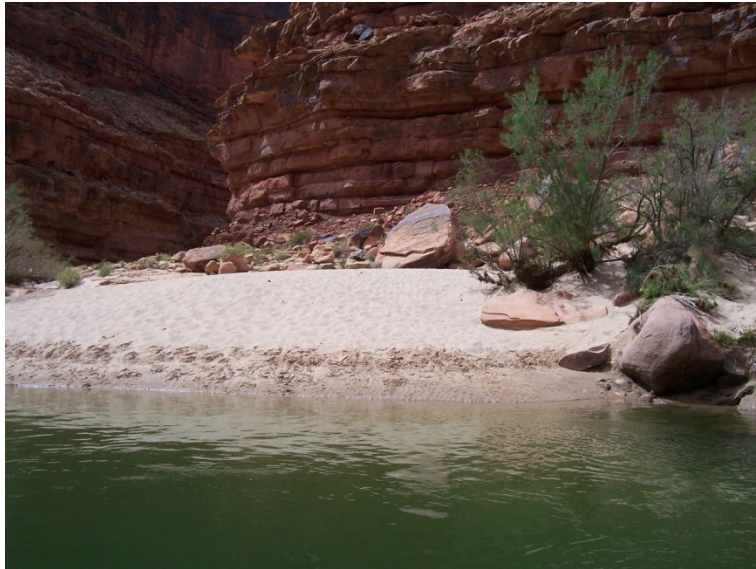
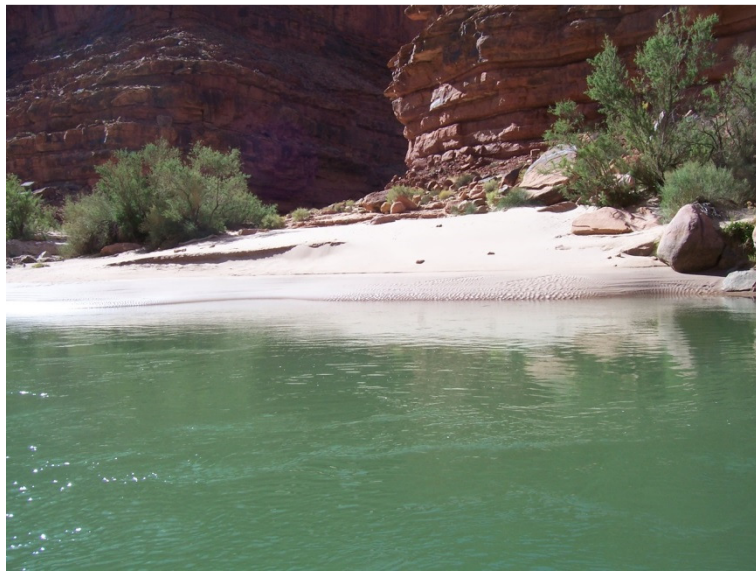
Figures 12 & 13. Upper North Canyon Camp, RM 20.7 R April 2, 2013 (top) and October 30, 2013 (bottom). Exposure of bedrock and large boulders above the high water line indicates wind erosion of beach.

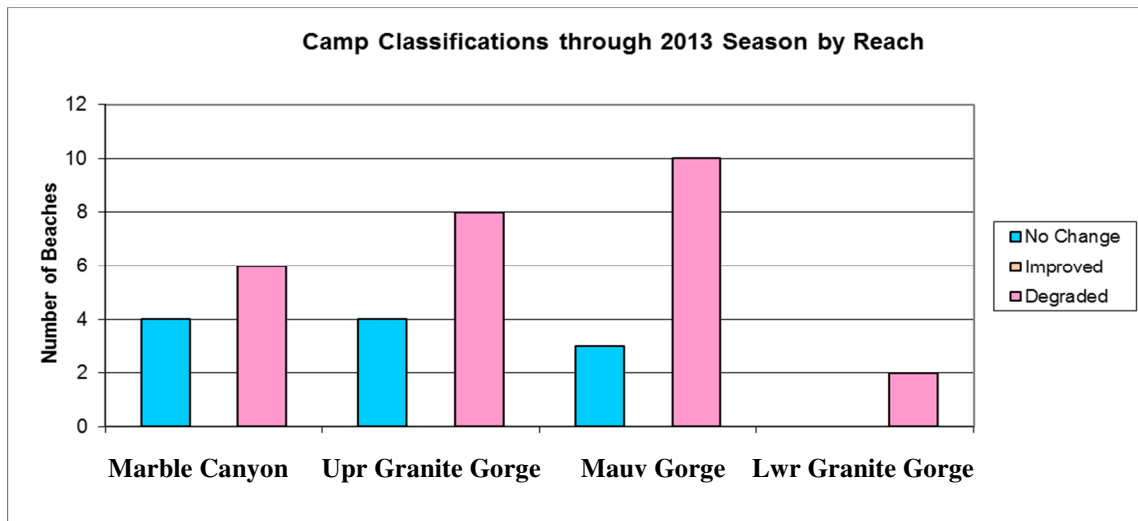
For the time spanning the 2013 summer boating season, photos were used which spanned from early April to early November, with the average fall season ending date being October 12. Thirty seven of the 44 study beaches in the program had photographs and photographer comment sheets spanning a sufficient period of time to be evaluated. The highest release flows during the season started July 1 and continued through August, and with few exceptions, the earliest season ending date considered was September 1. Only three of the beaches were orphaned after the initial April photo set, but 4 others were not photographed late enough in the year to be considered for a complete season. Of the 37 beaches included in this portion of the analysis, 30% did not show significant changes, and were classified as Unchanged through the season. Twenty six of the beaches, just over 70%, were Degraded through the summer. None of the beaches evaluated were considered Improved in the Fall of 2013. Those beaches classified as Unchanged were distributed fairly evenly through the upper three reaches, with 4 in the Marble Canyon reach, 4 also in the Upper Granite Gorge reach and 3 residing in the Muav Gorge reach. Of the three beaches found in the Lower Granite Gorge reach, none was considered as Unchanged. The

26 Degraded beaches were located in each of the four reaches, with 23% in Marble Canyon, 31% in the Upper Granite Gorge, another 38% distributed through the Muav Gorge and 8%, or two the three beaches, in the Lower Granite Gorge.

The most often cited cause of beach degradation this season was the erosion by fluctuating flows, particularly the higher flows during the second half of the season, but rain events had a greater impact overall. Incision of camps by rain runoff was found throughout the Grand Canyon but tributary flows were catastrophic in both the Muav Gorge and the Lower Granite Gorge for the second year in a row. Wind deflation of camps was also a frequent cause of erosion and was a severe enough agent to warrant a classification of Degraded in a couple of instances.

Figure 14. Graphic illustration for 2013 seasonal evaluations
