ADOPT-A-BEACH PROGRAM

Long-Term Monitoring of Camping Beaches in Grand Canyon

Summary of Monitoring Observations for 2018

*By
Paul Lauck¹*

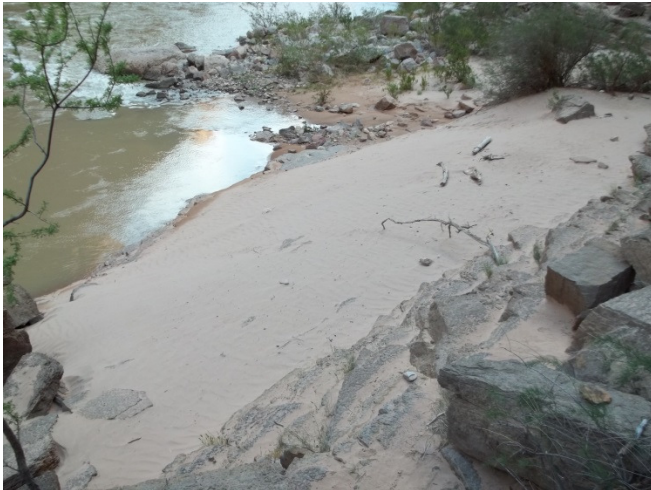
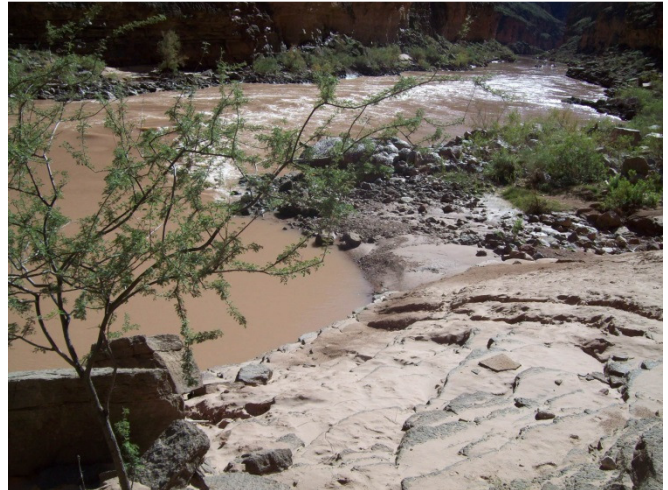
*Example of camp degradation due to both wind scour and rain events. Last Chance Camp, RM 156.26R
Photo on left taken April 12, 2018, on right October 31, 2018*

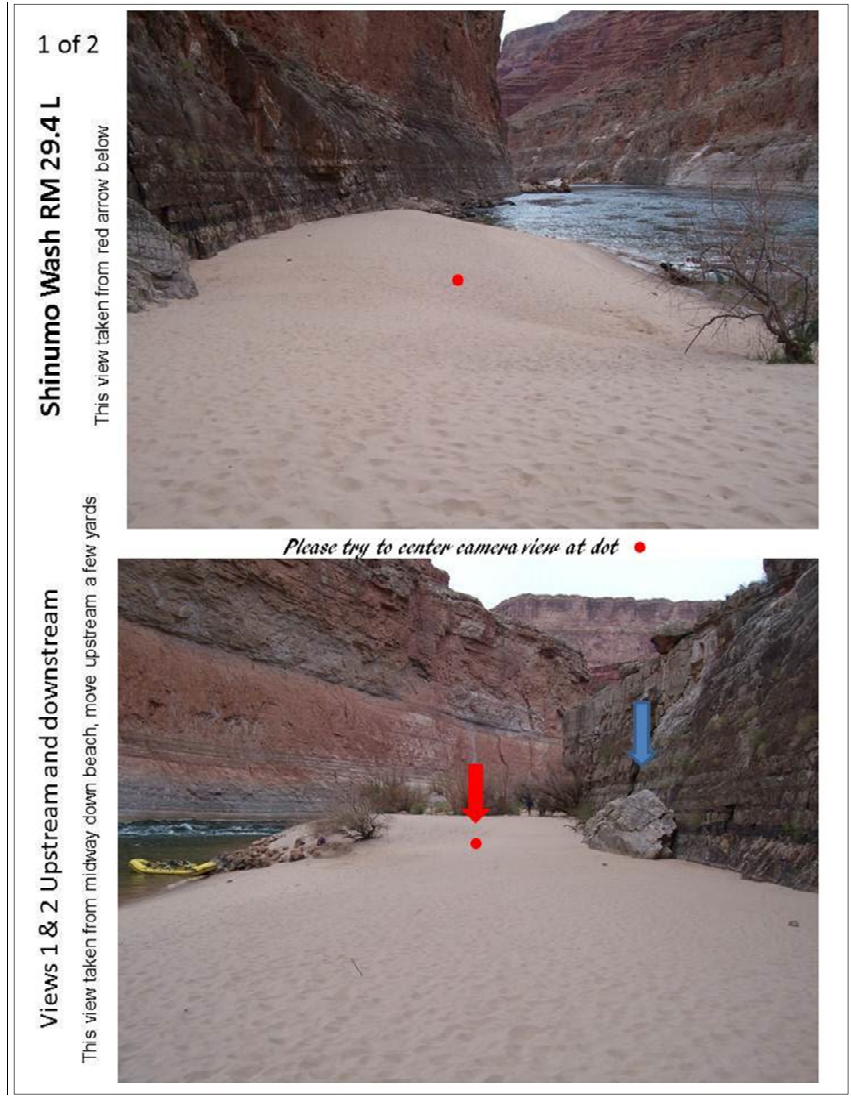
Figures 2 & 3. Examples of reference sheets supplied to volunteers directing photographer on where to stand and which views should be acquired.

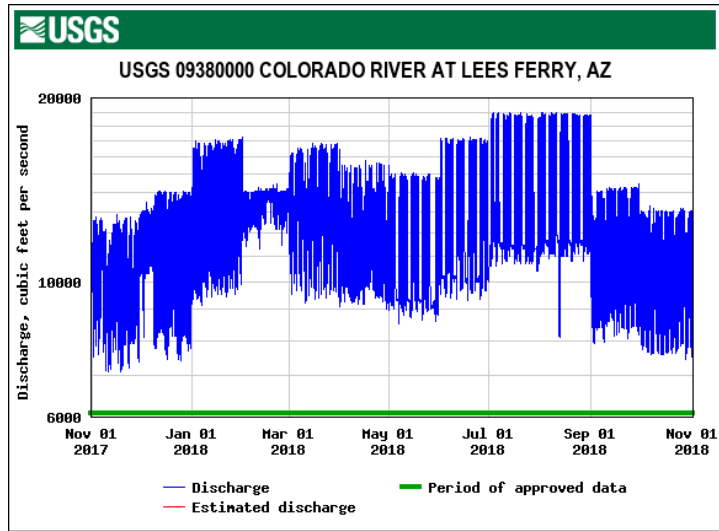
Figure 4. Flow graph for Colorado River at Lees Ferry, AZ., November 1, 2017 through November 1, 2018

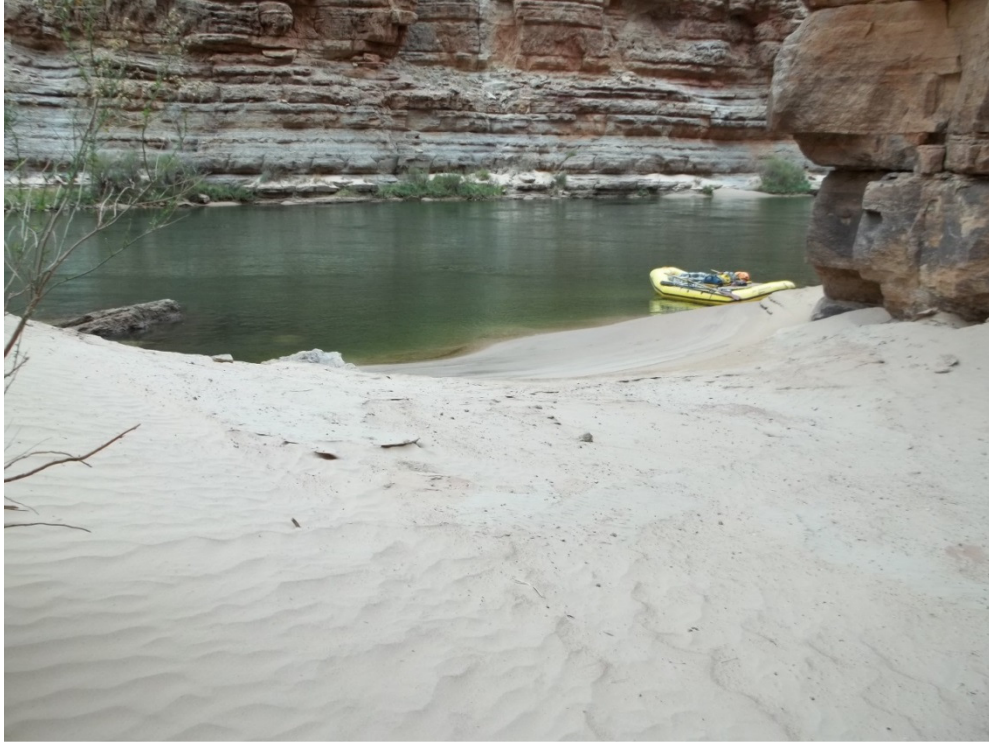
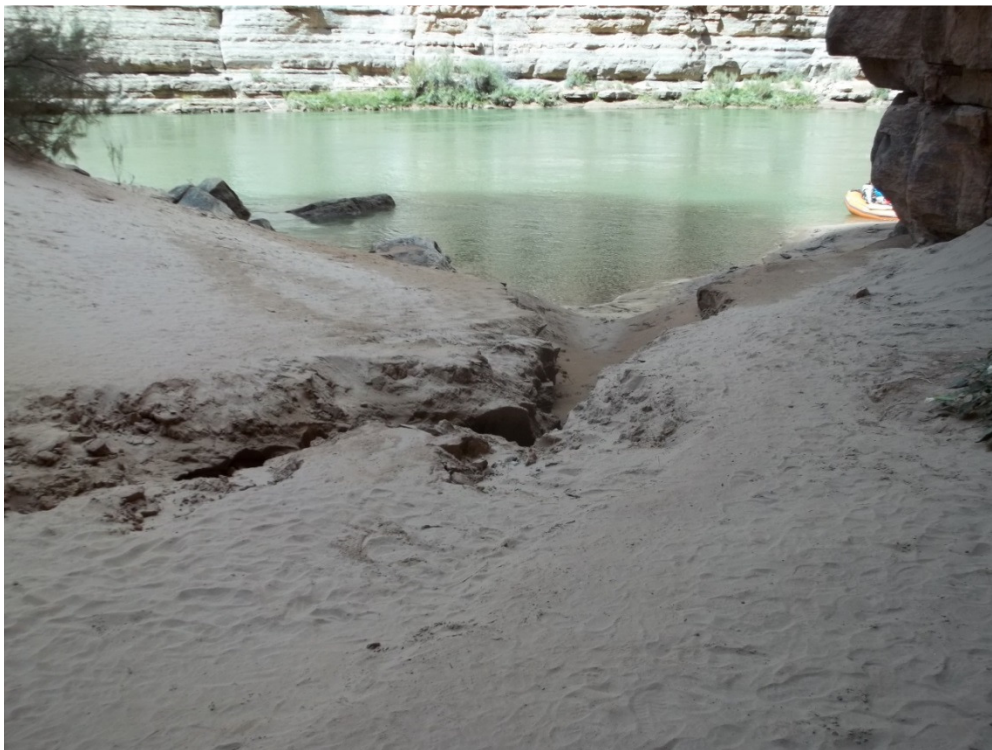
Figures 13 & 14. Documentation of beach degradation following rain event. Martha's Camp, RM 38.6 L, April 4, 2018 (upper) and September 1, 2018 (lower).

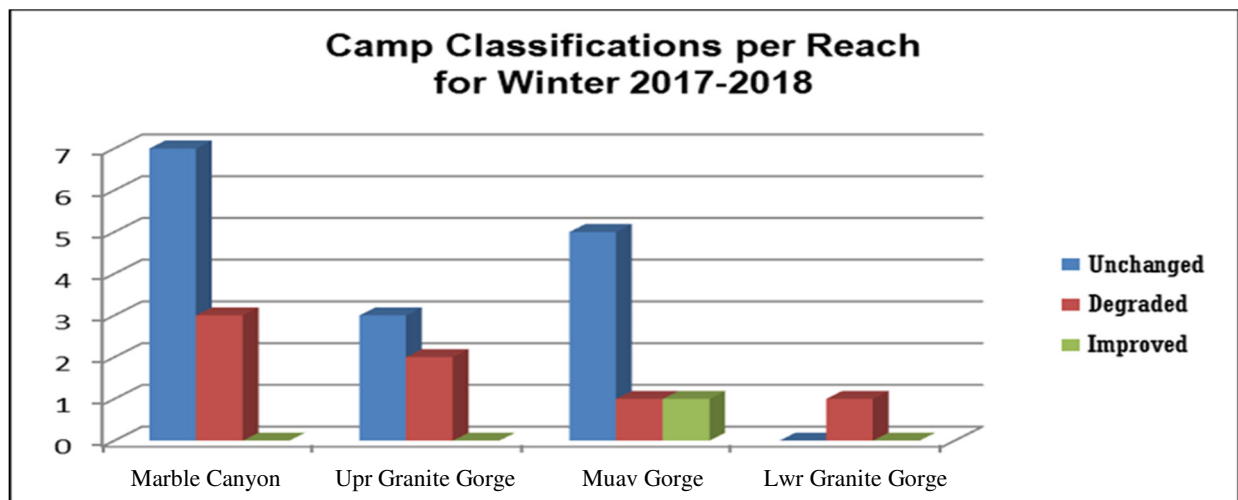
Five of the 7 beaches which Degraded during the winter had sand eroded from the camp front, probably from fluctuating flow dam releases. One had Degraded through obvious wind scour, which was also a secondary factor at two additional camps, and one beach suffered from human traffic erosion. Distribution of the 15 beaches with Unchanged classification include 7 in the Marble Canyon reach, 3 located in the Upper Granite Gorge and 5 found in the Muav Gorge. There are three beaches with a Degraded classification in the Marble Canyon reach, 2 located in the Upper Granite Gorge and one each in the Muav Gorge Lower Granite Gorge reaches. See figure 15.

Figure 15. Graphic illustration for Winter 2017 to 2018 evaluations per Reach.

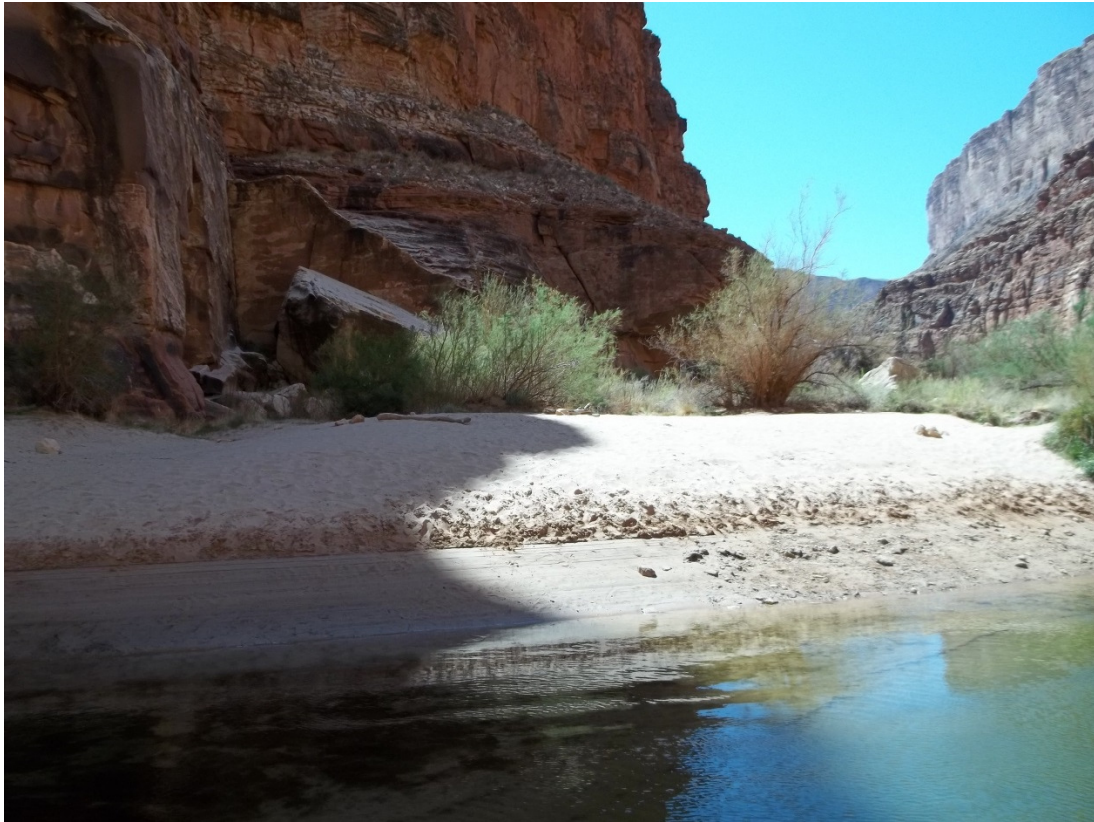
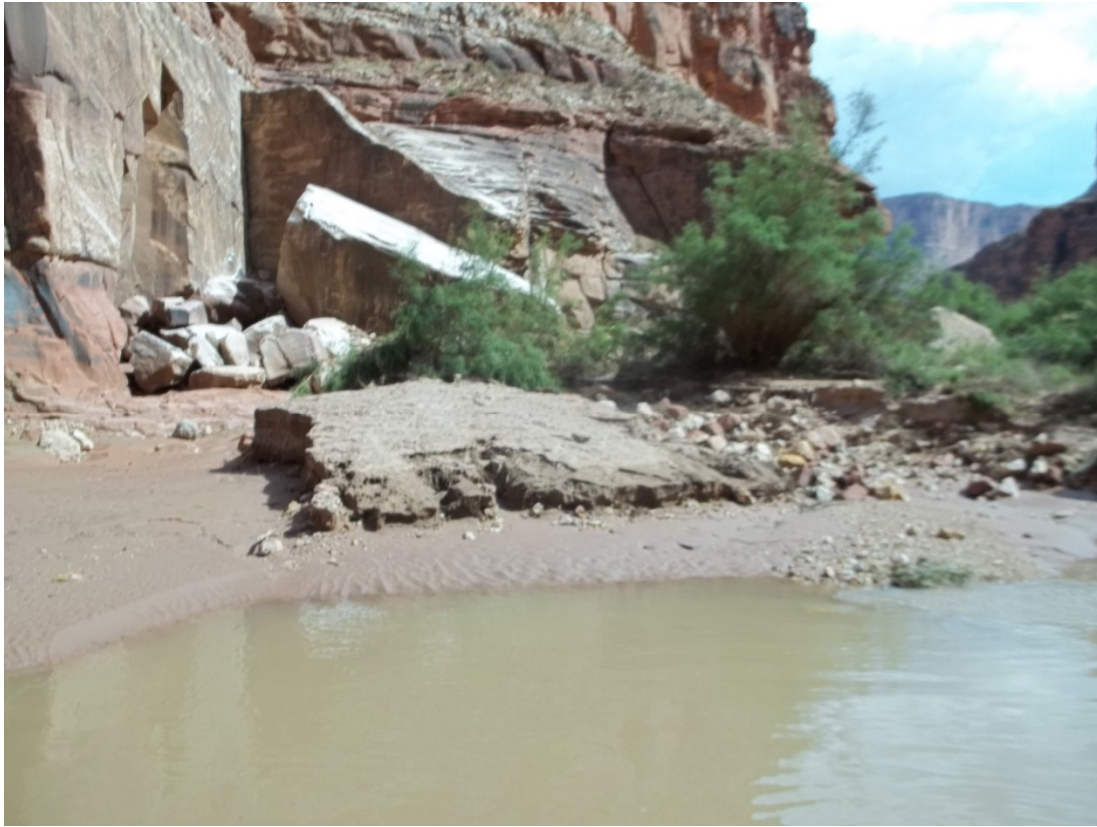
Figures 18 & 19. Documentation of beach degradation following rain event. Hot Na Na Camp, RM 16.6 L, April 3, 2018 (upper) and July 19, 2018 (lower).
