ADOPT-A-BEACH PROGRAM

Long-Term Monitoring of Camping Beaches in Grand Canyon

Summary of Monitoring Observations for 2019

December 17, 2020

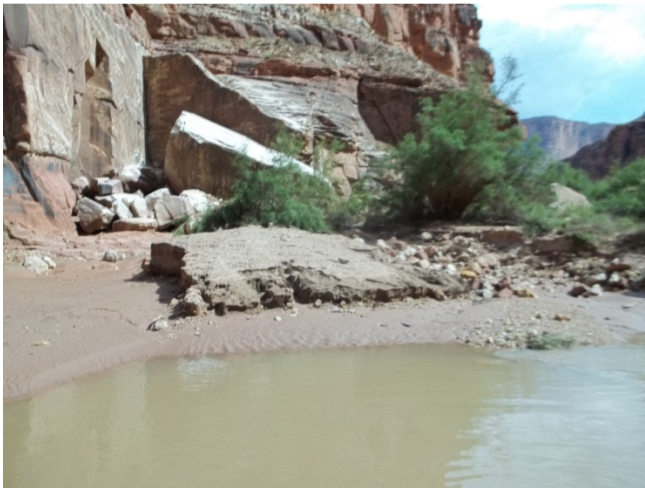
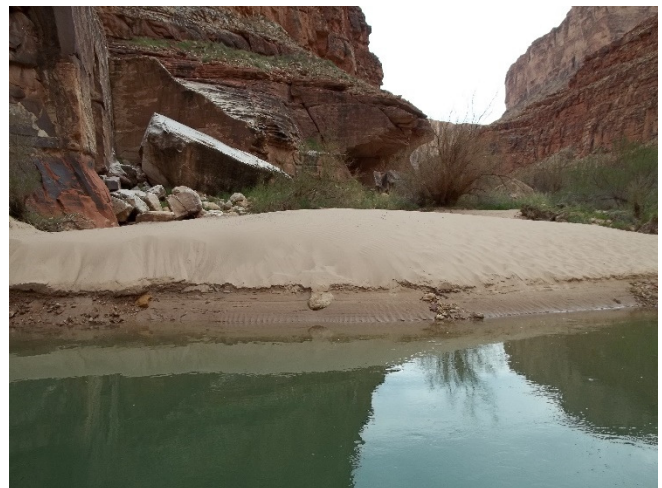
Hot Na Na Camp, RM 16.6L

Example of camp restoration resulting from the early November 2018 High Flow Experiment event.

Photo on left taken July 19, 2018, on right April 1, 2019

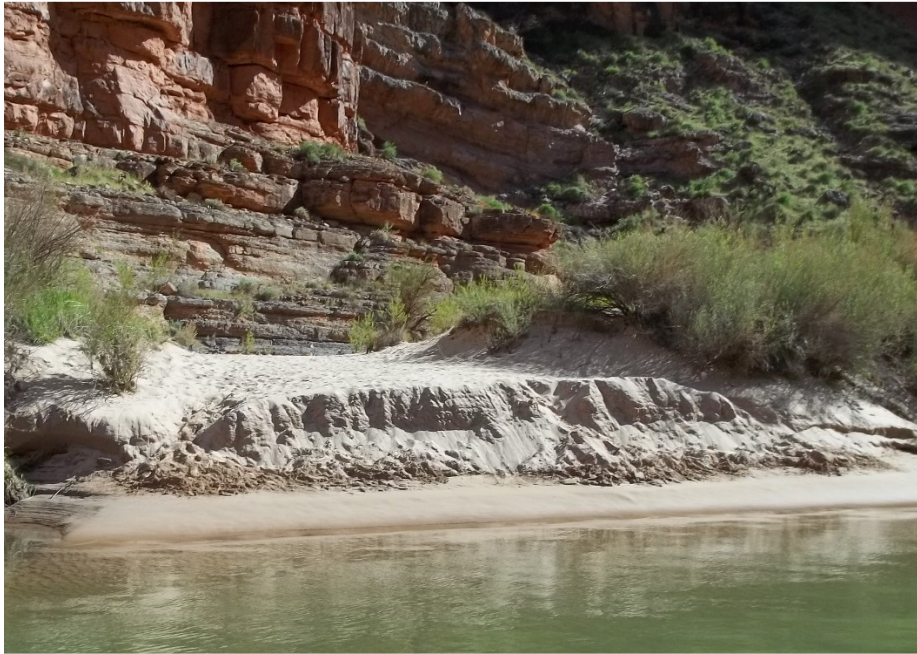
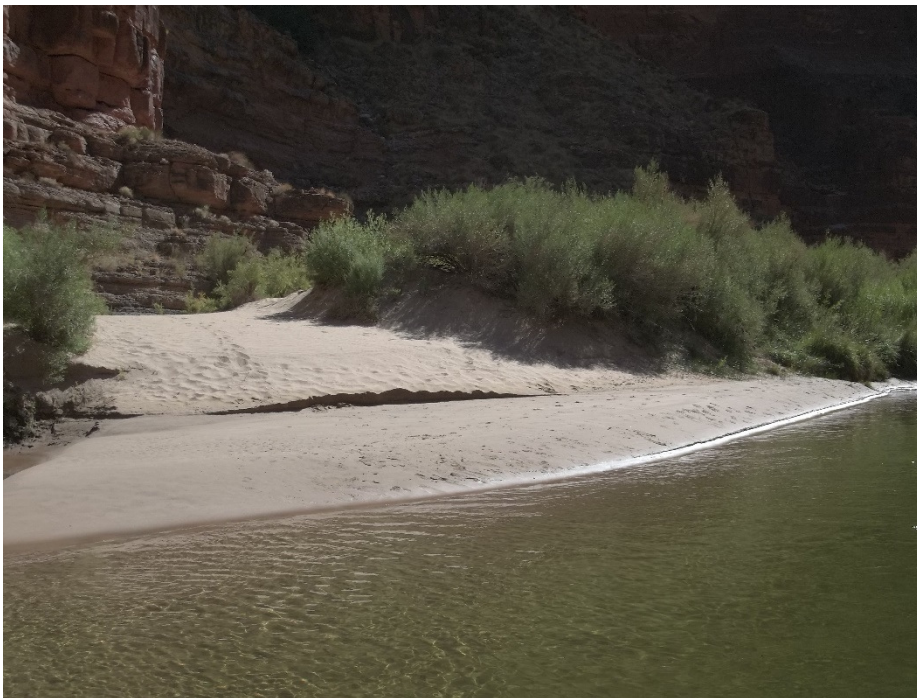
Figures 15 & 16. Documentation of beach access Improvement through a combination of human traffic and fluctuating flows. Tatahatso Camp, RM 38.6 L, April 2, 2019 (upper) and September 13, 2019 (lower).

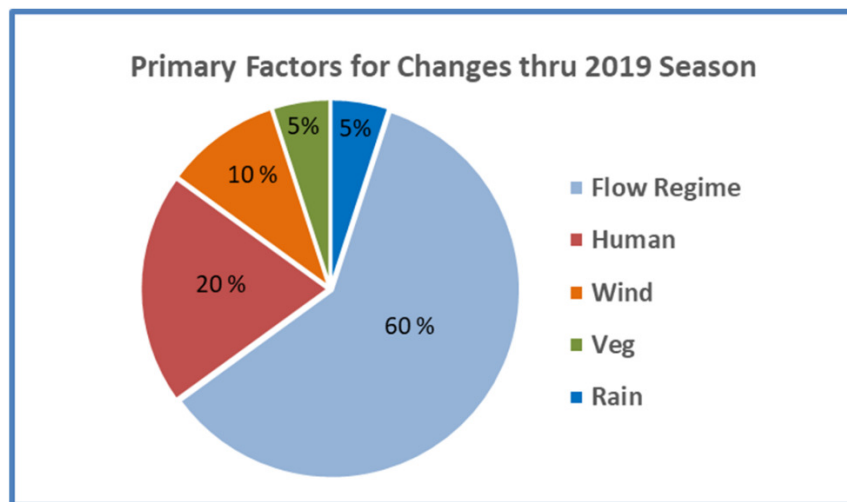
Figure 18. Graphic illustration for factor frequencies behind any change during 2019 season

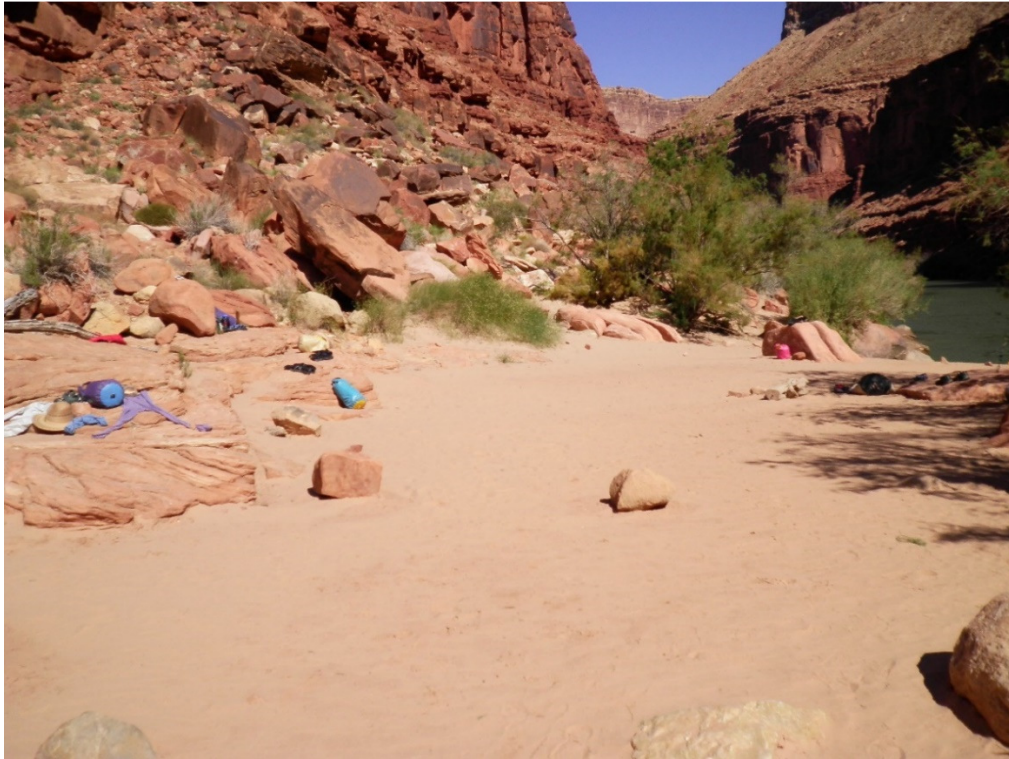
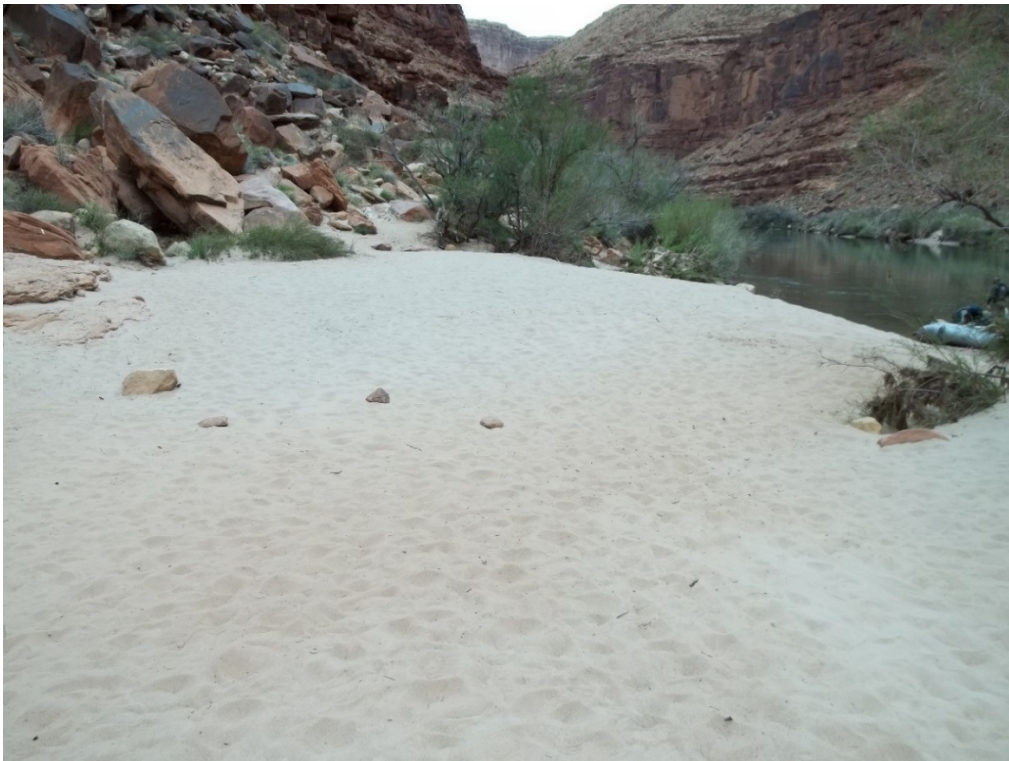
Figures 19 & 20. Documentation of sand deposition during November 2018 High Flow Experiment. Upper North Canyon Camp, RM 20.7 R, October 15, 2018 (upper) and April 2, 2019 (lower).

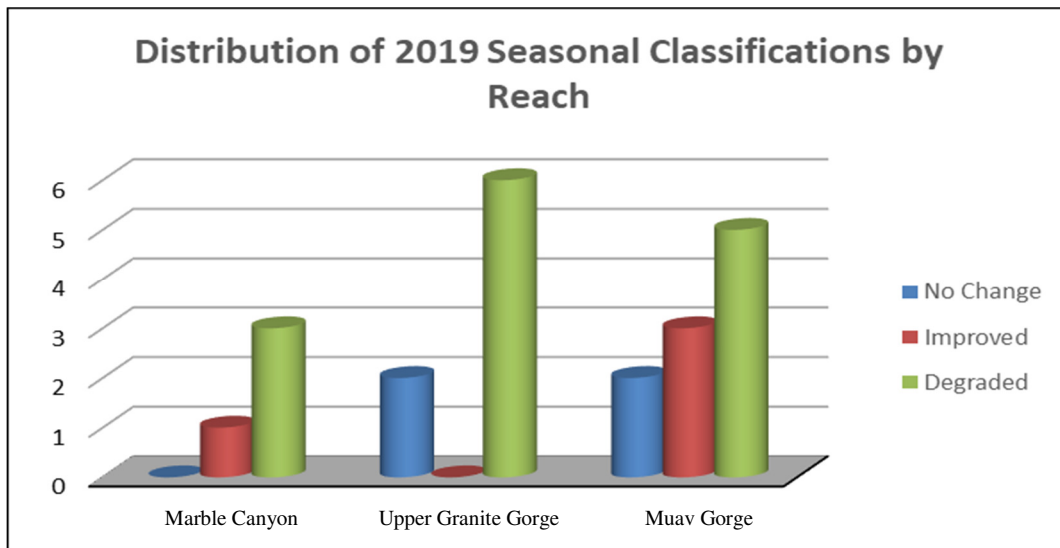
Figure 21. Graphic illustration for 2019 classifications by reach

There were 14 beaches classified as Degraded in the study and were distributed throughout the first three reaches. There were 3 (21%) found in Marble Canyon, 6 (43%) in the Upper Granite Gorge, and 5 (36%) distributed through the Muav Gorge. (See Figure 21).
