Long Term Monitoring of Camping Beaches In Grand Canyon

Summary of Results for 2011 with Comparisons to Observations of the 1996 Beach Building/Habitat Flow

*Annual Report of Repeat Photography
By Grand Canyon River Guides, Inc.¹
(Adopt-A-Beach Program)*

Adopt – A – Beach:
Long-Term Monitoring of Camping Beaches in Grand Canyon
Summary of Monitoring Observations for Year 2011

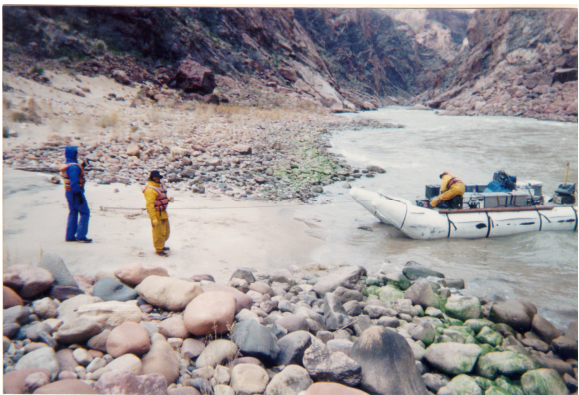
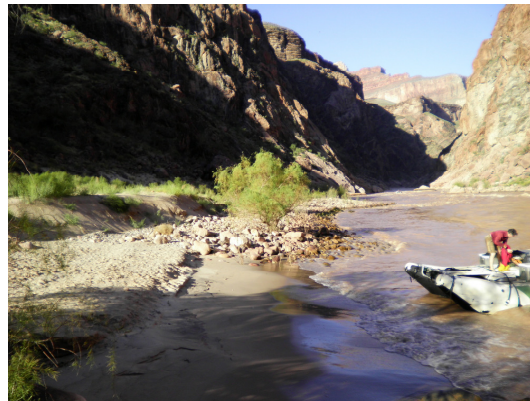
*Lower Tuna Camp, RM 99.7 L February, 1996
Lower Tuna Camp, RM 99.7 L September, 2011*

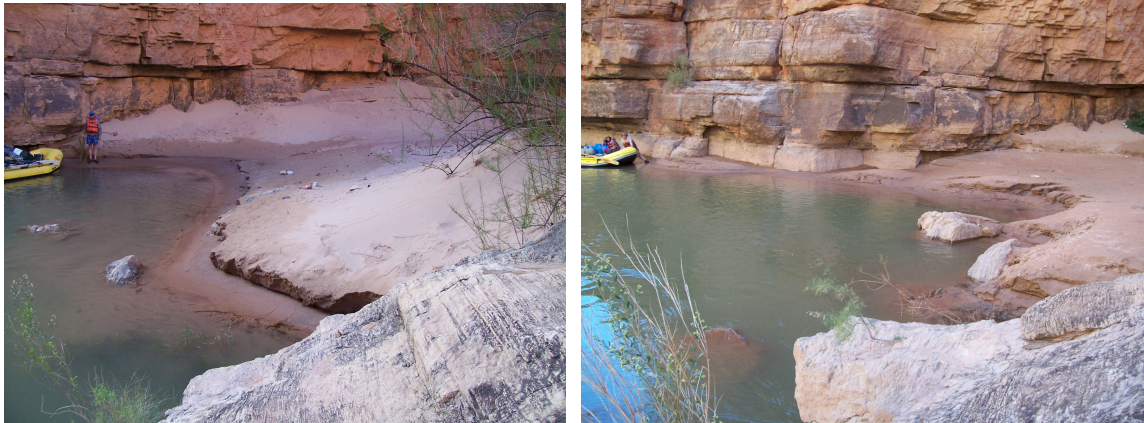
Figure 2 & 3. Martha's Camp RM 38.3 L. Photo on left taken 4/3/11, right taken 9/22/11. Documented change in beach front erosion for 2011 season.

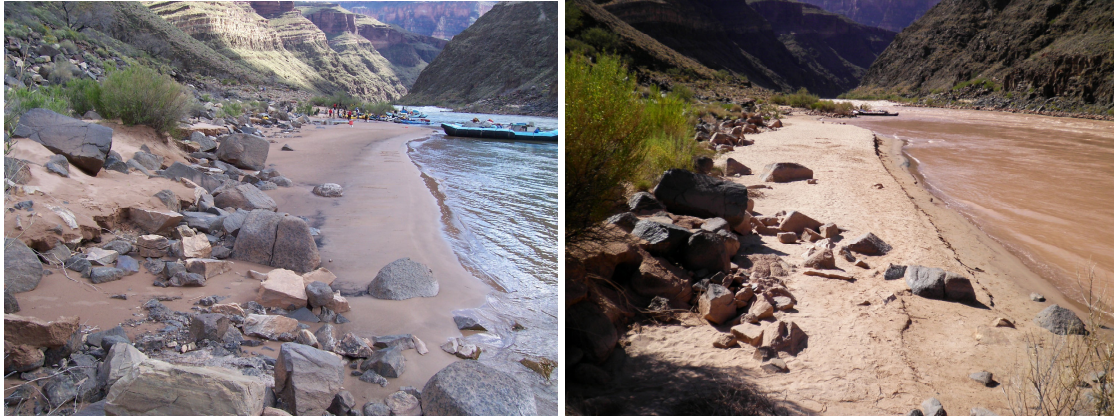
Figure 4 & 5. Stone Creek Camp, RM 132.0 RL, 04/10/11 (left) and 9/23/11 (right) display camp expansion from late season deposition.

The images being compared were then examined progressively from front to back to note the absence or addition of rocks or other debris which would impact the total area being used as a camp. The location and visual extent of emerging rocks can usually indicate the physical action which occurred to reveal the rocks. As an example, rocks which were covered in image “A” by sand, covered by river flow in image “B” and subsequently revealed as the water level receded, are noted as indicators of river flow erosion. Conversely, the reverse action would be noted as an indicator of sediment deposition. The lower (downstream) end of Stone Creek Camp would be a good example of both of these results.

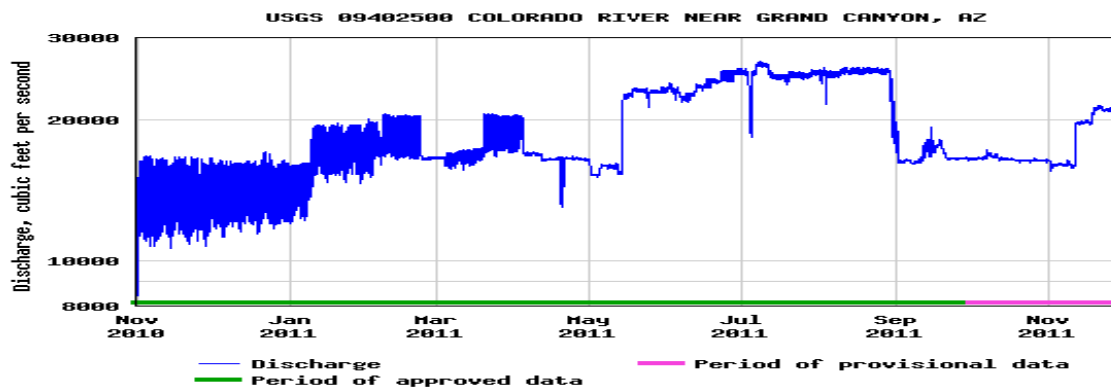
Figure 7. Flow graph for Colorado River near Grand Canyon, AZ., 2011

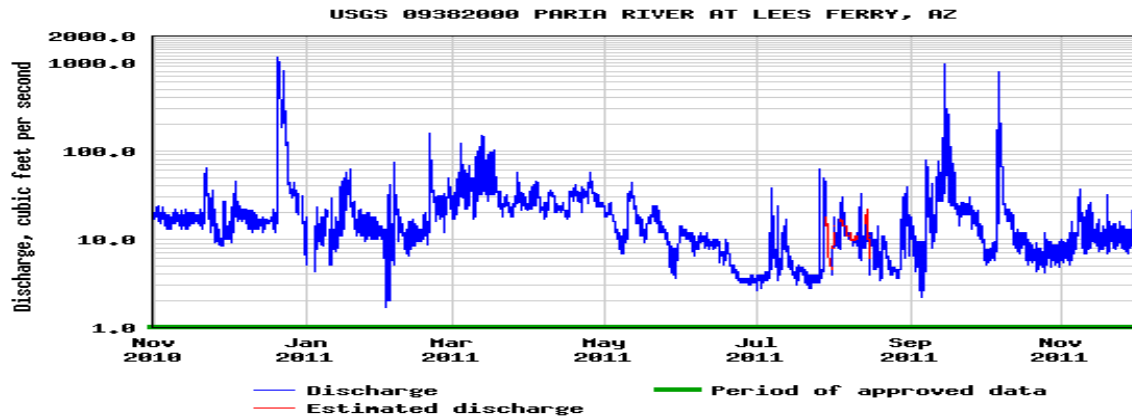
Figure 9. Flow graph for Paria River at Lees Ferry, AZ., 2011

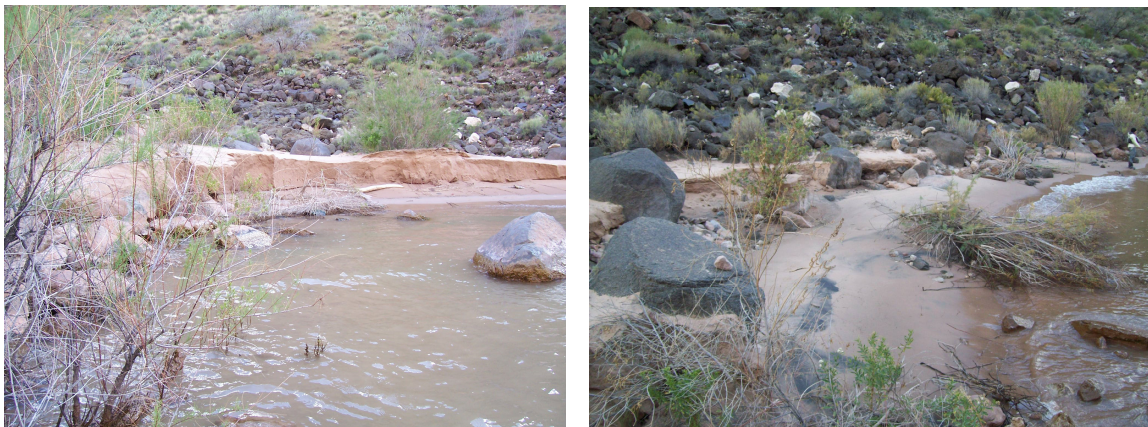
Figures 10 & 11. Talking Heads Camp, RM 133.0 L April 10, 2011 (left) and December 1, 2011 (right) documenting progressive beach loss due to high releases.

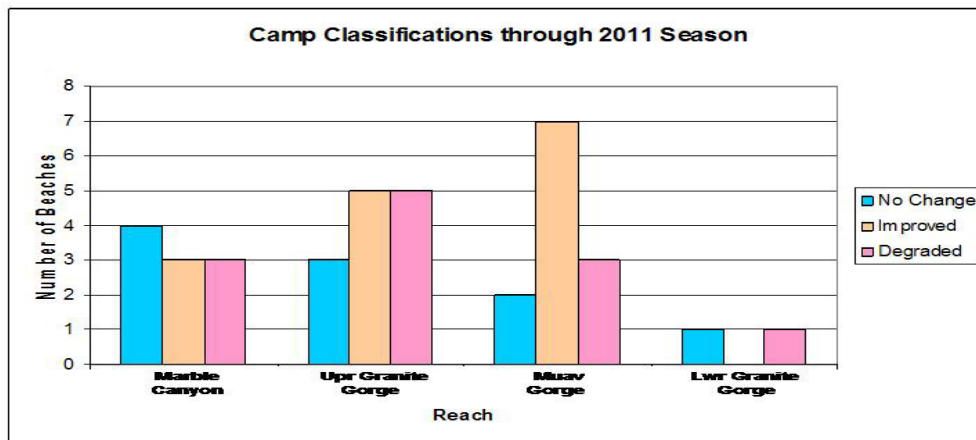
For the time spanning the 2011 summer boating season, early April to mid-November, 37 of the 44 study beaches in the program had photographs and photographer comment sheets spanning a sufficient period of time to be evaluated. Of these 37 beaches, 27% were classified as Unchanged for the time period, 41% had Improved through the summer and 32% were considered as Degraded by the end of the season. Of

the Unchanged beaches, 40% are located in the Marble Canyon reach, 30% in the Upper Granite Gorge reach, another 20% are contained in the Muav Gorge reach and one, or 10%, is in the Lower Granite Gorge. Twenty percent of the Improved beaches are located in the Marble Canyon reach, another 33% in the Upper Granite Gorge and 47% are found in the Muav Gorge reach. Neither of the two beaches included in the study this year and located in the Lower Granite Gorge was considered to have improved. For the beaches classified as Degraded for this time period, 25% are from the Marble Canyon reach, 42% are found in the Upper Granite Gorge, 25% in the Muav Gorge reach and one, or 8% was located in the Lower Granite Gorge reach. The primary factor cited as creating an Improved camp is an increase of sand on the beach front enlarging the beach and creating more favorable parking for boaters. This is attributed to deposition from river transported sediment or sand being moved downslope and forward to the beach front by the extended flows in excess of 20K cfs through much of the season. An addition of sediment during September tributary inflows may also have been a factor. Due to the prolonged release of high water during this season, few if any noticeable changes could be readily identified during the mid-May through August time period. Beach front erosion and severe cutbanks as a result of the higher seasonal flows are the most readily evident cause of Degradation. Another factor often sited was vegetation increase/encroachment. One tributary flash event, at Trinity Camp, was noted by both the volunteer photographer and the analyst, and did have a significant effect.

Figure 12. Graphic illustration for 2011 seasonal evaluations

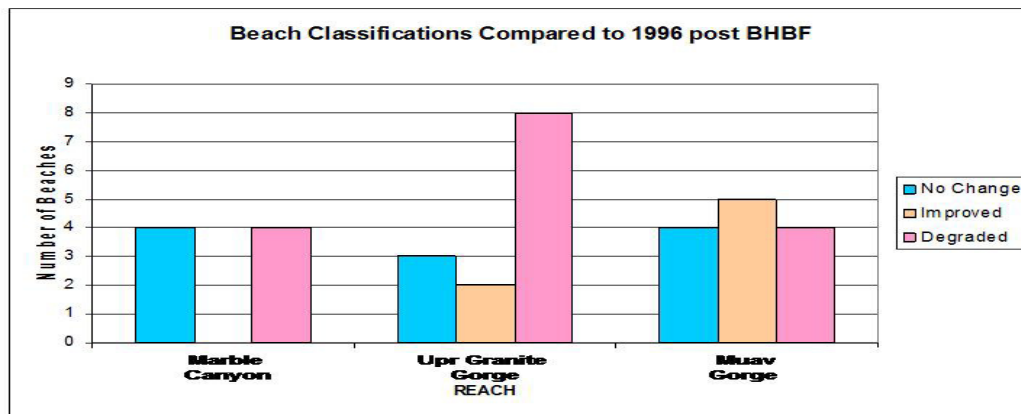
Thirty three of the Adopt-A-Beach camps photographed in 2011 were available for comparison to the post-BHBF mid-season photographs acquired in 1996. Of these, 32% were considered to be about the Same condition now as in 1996, 21% were classified as remaining Improved since the BHBF and 47% have Degraded beyond their post BHBF condition.

When divided into their respective reaches, 50% of the beaches located in Marble Canyon were classified as Same and 50% were considered as Degraded. No beach located in this reach was considered to be Improved when compared to the 1996 images. Twenty-three percent of the beaches in the Upper Granite Gorge reach were classified as Same or Unchanged when compared to the 1996 photos, 62% received a Degraded classification and 15% of the beaches are considered as having improved since the 1996 BHBF. In the Muav Gorge reach 31% received a Same as 1996 designation, 31% have Degraded and 38% have Improved since the 1996 event. None of the beaches currently being studied in the Lower Granite Gorge was photographed in 1996.

For those beaches rated as Improved when compared to the post BHBF images, most had a greater camping area available at the end of 2011, particularly toward the rear of the camp area. This can possibly be attributed to sediment deposition from subsequent High Flow Experiments and reworking of the sand by wind action. The most predominant cause cited for a Degradation classification was a marked increase in vegetation, both surrounding the camp area and in the interior areas. Erosion of beach fronts from the recent seasonal flow regime also factored into many of the Degradation ratings.

Figure 13. Graphic illustration of 2011 beaches compared to post 1996 BHBF

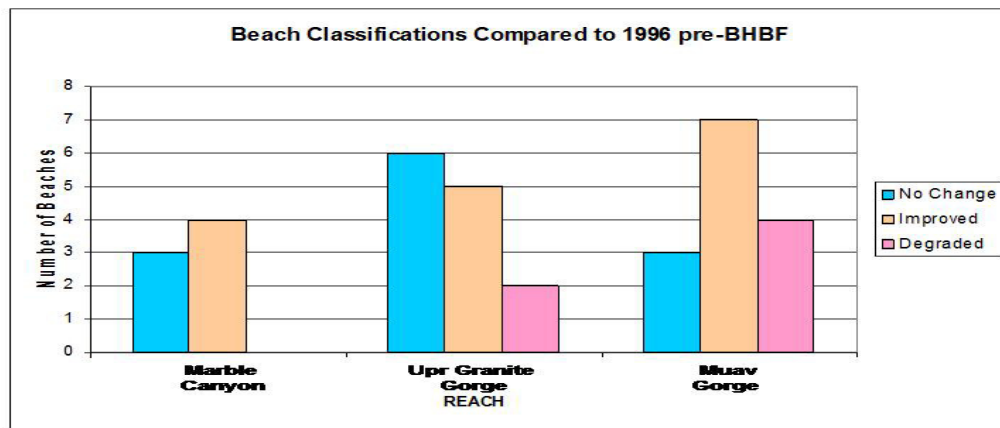
Of the 34 beaches considered in this portion of the analysis, 35% of the beaches were classified Unchanged, 18% are considered to be Degraded relative to the 1996 images, and 47% are Improved.

The following proportions were recorded per reach for these beaches. In the Marble Gorge, 43% were classified as Unchanged and 57% were recorded as being Improved compared to their 1996 pre-BHBF event conditions. None had degraded beyond the first image condition recorded by the study. Only seven of the eleven beaches currently being monitored in this reach were photographed during that first event. In the Upper Granite Gorge reach, 46% appeared to be the Same as in 1996, only two of the thirteen beaches considered, or 15% in this reach were classified as Degraded and 38% have an Improved appearance. Twenty-one percent of the beaches located in the Muav Gorge reach currently have a Same classification, 29% are considered Degraded compared to the 1996 images and a strong 50% are recorded as Improved.

Most of the beaches considered as Improved when compared to the pre-BHBF are cited as having an expanded camp area and sand increase in general. Those beaches classified as having a more Degraded appearance in 2011 were largely impacted by vegetation increases and, to a lesser extent, loss of beach front from river flow erosion.

Figure 14. Graphic illustration for 2011 beach classifications compared to 1996 pre-BHBF .
